CONDUIT INSPECTION REPORTING CODE OF AUSTRALIA

Version 4.1

WSA 05-2020

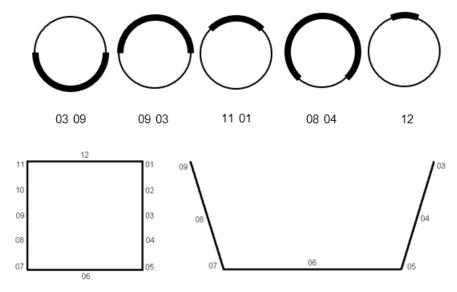
Figure 2.1 EXAMPLES OF CLOCK FACE REFERENCES

Where specified in <u>2.7 CODES FOR REPORTING THE INSPECTION OF CONDUITS</u> for each code, the position of a feature within the cross section shall be recorded using the hours of an imaginary clock face reference under <u>Table 2.2</u>. The imaginary reference clock shall be positioned at the centre of the <u>conduit</u>, 12 o'clock being vertically upwards (see <u>Figure 2.1</u> for examples).

Where <u>2.7 CODES FOR REPORTING THE INSPECTION OF CONDUITS</u> requires that the start and finish clock face references be given these shall be recorded in the clockwise direction. The circumferential location of a feature occupying the entire periphery shall be recorded as "from 12 o'clock to 12 o'clock". Where the feature or defect requires only a single clock face reference this shall relate to the centre/mid-point of the feature.

Clock references shall be given to the nearest hour, as shown in examples given in Figure 2.1.

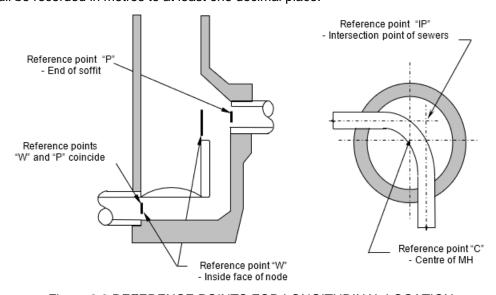
Figure 2.2 REFERENCE POINTS FOR LONGITUDINAL LOCATION

The location of each feature shall be specified by stating the distance in metres from the reference point at the start of the inspection. The reference point shall be one of the following (See also <u>Figure 2.2</u>):

- (a) 'W' inside face of the wall of the starting node e.g. MC, MH, MS, IS or outfall at the point where the *conduit* passes through the wall;
- (b) 'P' soffit of the end of the *conduit* length inside the starting node. This will be the same point at described in (a) above except where the conduit projects into the MH. This is the preferred reference point;
- (c) 'C' centre of the starting maintenance structure, generally a MC, MH or MS;
- (d) 'IP' intersection of the incoming and outgoing conduit, measured along the channel; or
- (e) Adjacent surface level (when inspecting a vertical conduit).

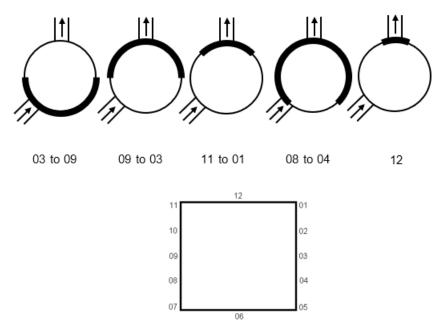
Figure 3.1 CLOCK FACE REFERENCES IN SHAFTS OF MAINTENANCE STRUCTURES

Where specified in 3.7 CODES FOR REPORTING THE INSPECTION OF MAINTENANCE STRUCTURES for each code, the position of the feature around the circumference of the maintenance structure (or perimeter for non-circular maintenance structures) shall be recorded using the hours of an imaginary clock face reference under Table 3.1. The imaginary reference clock shall be set relative to the outgoing sewer (see Figure 3.1) as defined in code CBD (refer to 3.6.3 Header codes for reporting inspection details). It is recommended that the imaginary clock be set with 12 o'clock to the outgoing sewer (CBD = T).

Where 3.7 CODES FOR REPORTING THE INSPECTION OF MAINTENANCE STRUCTURES requires that the start and finish clock face references be given these shall be recorded in the clockwise direction. The circumferential location of a feature occupying the entire periphery shall be recorded as "from 12 o'clock to 12 o'clock". Where a code only requires only a single clock face reference this shall relate to the centre/mid-point of the feature.

Clock references shall be given to the nearest hour, as shown in examples given in Figure 3.1.

Code	Description		
HST	Records information about the node at the start of the inspection (refer to Figure 3.1 for manholes)		
	Addit	Additional Information	
		acterisation 1—Nature of start feature rd the type of feature as follows:	
	AC	Access cover	
	В	<u>B</u> enching	
	FSL	<u>F</u> inished <u>s</u> urface <u>l</u> evel	
	L	<u>L</u> anding	
	RS	Reducing or conversion slab	
	Z	Other—record details in remarks

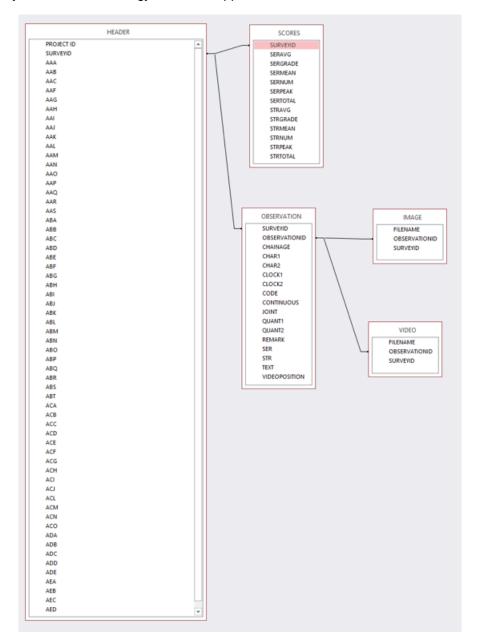
Figure A.1 DATA STRUCTURE FOR EACH INSPECTION

An example of the general structure for recording each conduit inspection can be depicted as shown in <u>Figure A.1</u>. This applies to conduits only, and the methodology should be applied for maintenance structures.

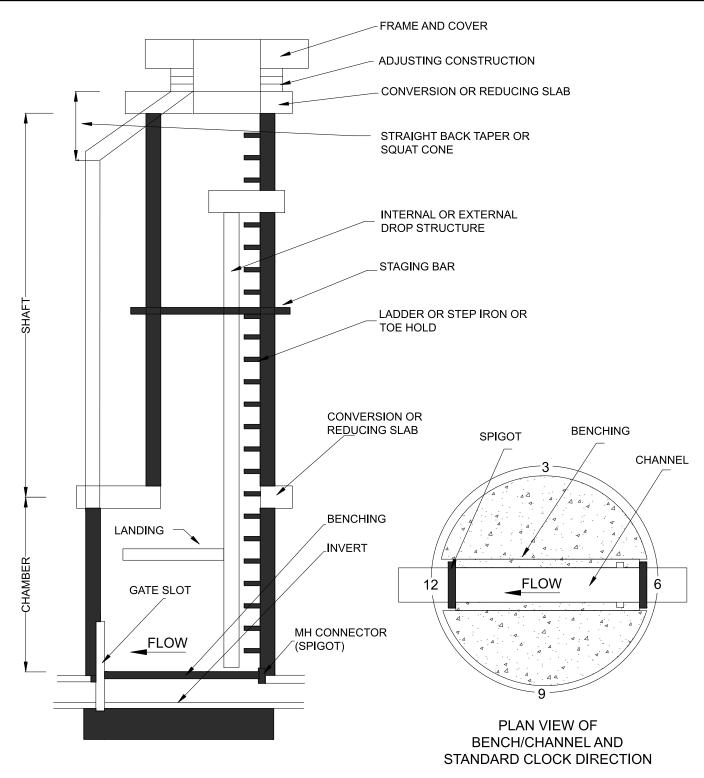
Figure E.1 ILLUSTRATION OF TYPICAL MH FEATURES

- (1) This figure is for general illustrative purposes only and is not technically correct with regard to location and scale of labelled MH features. The terms are consistent with Figure 3.1 of AS 4198—1994.
- (2) When there is one or less 'REDUCING SLAB' use 'CHAMBER' for the location of any wall defects.
- (3) Any defects for a landing structure (not shown in <u>Figure E.1</u>) should use the 'STEP/LADDER/TOE HOLD/ STAGING BAR' location and should be recorded as 'a landing' in the comments

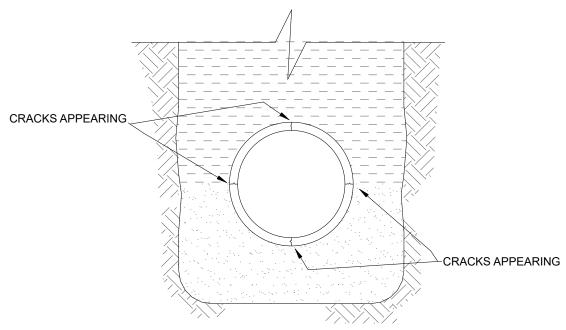
Figure F.1 STAGE 1 RING FAILURE PATTERN

Pipe cracking could be caused by poor installation, subsequent overloading or disturbance. The conduit remains supported and held in position by the surrounding soil. Pipes at this stage may be stable depending on the surrounding ground and hydraulic performance of the conduit. Cohesive soils surrounding the conduit generally reduce the risk of further deformation. Refer to Figure F.1.

- (a) Cracks at soffit, invert and spring line; and
- (b) Slight infiltration and or encrustation may also be visible.

Actual cracking patterns are likely to be an irregular approximation of the geometric design depicted in <u>Figure F.1</u> to <u>Figure F.3</u>, and is shown in <u>Figure F.4</u>. There will also be another crack in the invert.

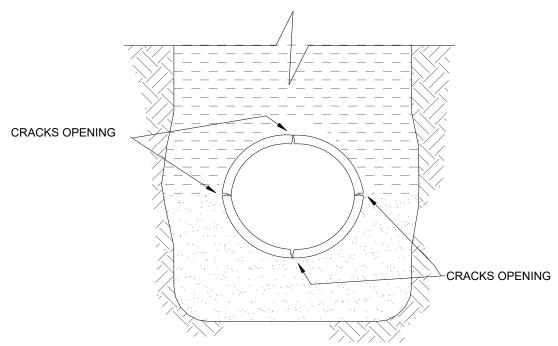
Figure F.2 STAGE 2 RING FAILURE PATTERN

Infiltration through cracks. Cycles of hydraulic overloading (surcharging) cause exfiltration/ infiltration in which the surrounding soil becomes saturated and then allows ingress of soil when surcharging subsides. Side support is reduced allowing some movement and further deformation.

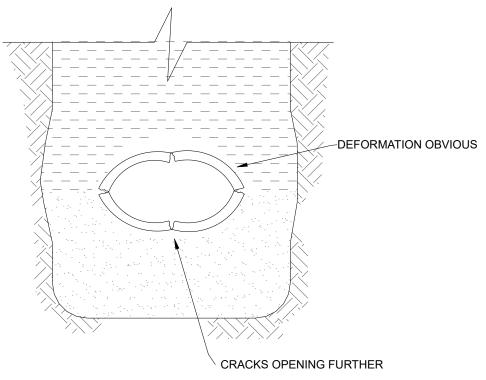
Figure F.3 STAGE 3 RING FAILURE PATTERN

Loss of side support allows side of pipe to move further outwards and the soffit to drop. It is considered broken at this stage or collapsed depending on percentage deformation. Once deformation exceeds 10%, the pipe becomes increasingly likely to collapse.

- (a) Cracks opening further in soffit and invert with pipe pieces misaligned;
- (b) Deformation is obvious; and
- (c) Spalling likely along the crack lines.

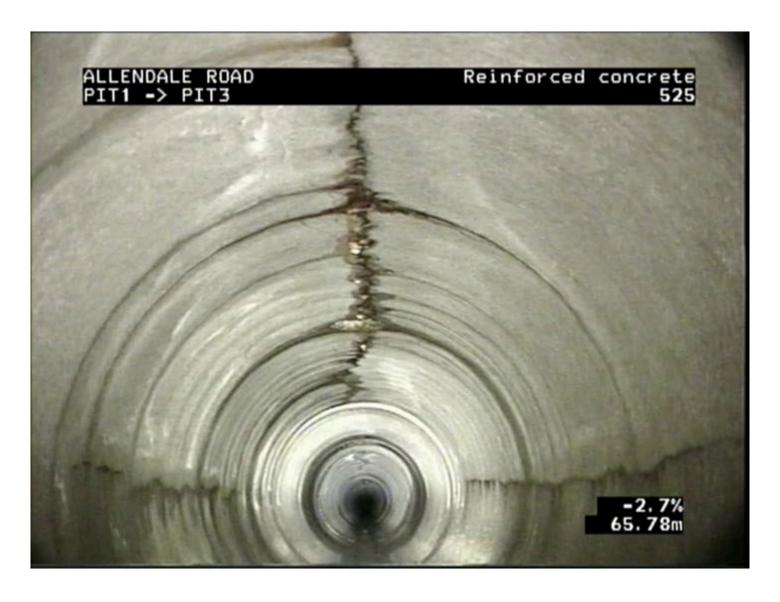
Figure F.5 EXAMPLE OF CRACKING WITH STAINING THROUGH RING FAILURE PATTERN

Another example of this form of cracking is in <u>Figure F.5</u>, which also shows staining from past infiltration along the crack lines.

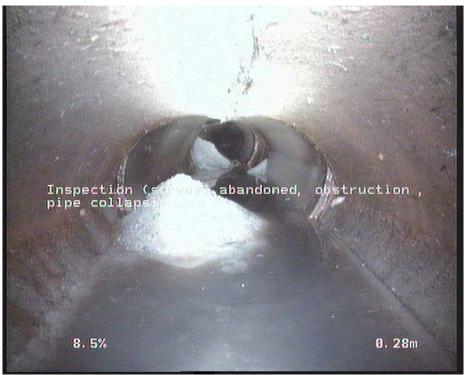
Figure F.6 EXAMPLE OF CRACKING THROUGH RING FAILURE PATTERN DUE TO LOSS OF SIDE SUPPORT

In this example shown in <u>Figure F.6</u>, side support has been lost, the joint has failed and the conduit is regarded as collapsed; overloading, poor construction and or inadequate pipe class may be the key factors in the collapse of this recently constructed stormwater drain.

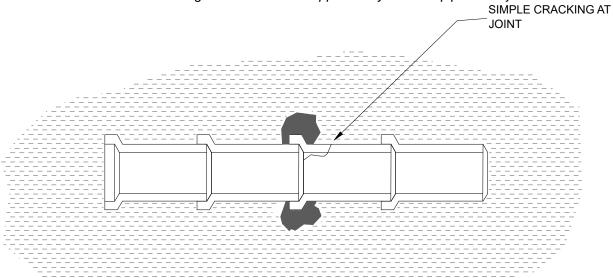
Figure F.7 STAGE 1 JOINT FAILURE PATTERN

There is a gap in the seal at the joint – cement mortar lost, rubber ring pinched or broken allows exfiltration and infiltration. Cycles of exfiltration and infiltration with ingress of soil takes support away from the pipe at the joint.

- (a) Some signs of exfiltration of infiltration at joint;
- (b) Ingress of fine soil particles may be apparent;
- (c) Joint displacement may be apparent; and
- (d) Simple cracking originating from the joint.

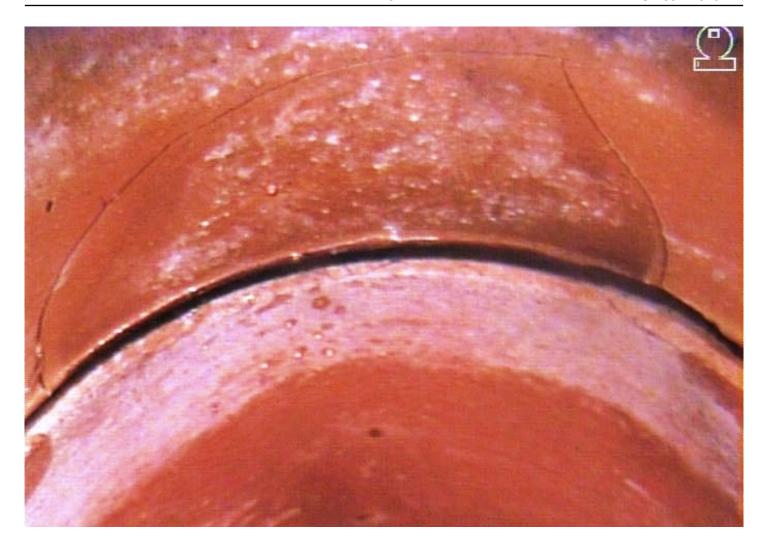
Figure F.8 EXAMPLE OF SIMPLE CRACKING THROUGH JOINT FAILURE PATTERN

The simple cracking phenomenon is shown in <u>Figure F.8</u>. It is typically associated with the socket end of the pipe in earthenware, vitrified clay and concrete pipes.

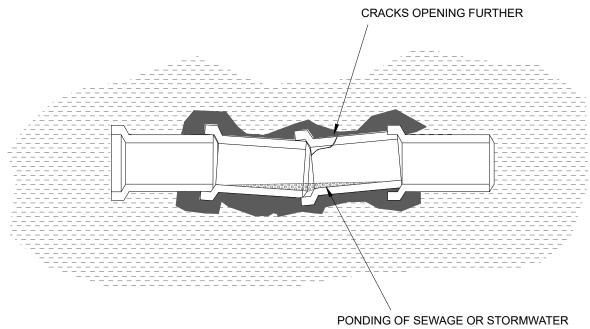
Figure F.9 STAGE 2 JOINT FAILURE PATTERN

Lack of support allows the pipe to assume an angular deflection at several joints. Simple cracks may open, and additional cracking in the stress zones may become obvious. In some situations, there may be no support left in the socket to restrain the spigot which would allow it to deflect radially.

- (a) Angular deflection at joints with simple cracking opening and other cracks appearing;
- (b) Ponding will be obvious with grade disrupted;
- (c) Spalling likely as pipe pieces move out of alignment; and
- (d) Soil visible or ingress of soil likely.

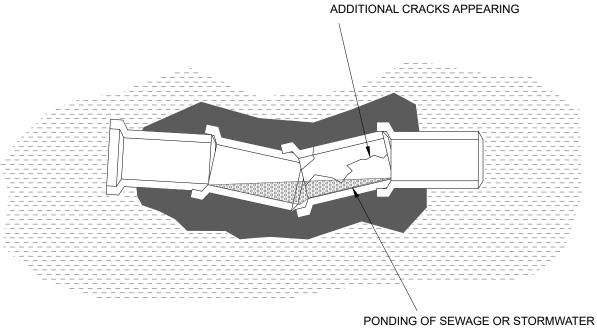
Figure F.10 STAGE 3 JOINT FAILURE PATTERN

Continuing loss of support allows the pipes to assume more extreme angular deflections at several joints, and joint integrity is lost. Simple cracking may allow a piece of pipe to be dislodged. Cracking in the stress zones likely. Spigots may move radially, with voids visible coupled with ingress of soil and/or exfiltration likely.

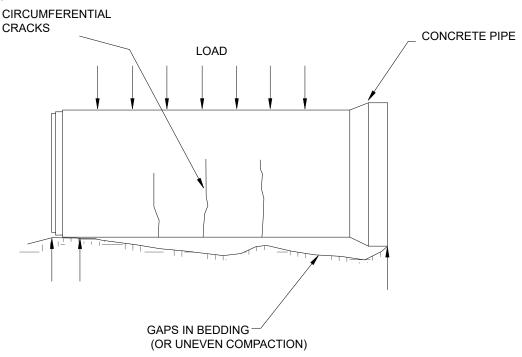
Figure F.11 BEAM FAILURE - SUPPORTED AT THE ENDS ONLY

In this example, as shown in <u>Figure F.11</u>, the pipe is only supported on the ends; pipes are laid with support only at the sockets and gaps below the pipe. Trench backfill and surface loads are exerted on the pipe, causing it to act as a beam. Circumferential cracking originates at the invert and extends towards the spring line. Cracking is generally concentrated at midpoint of the pipe.

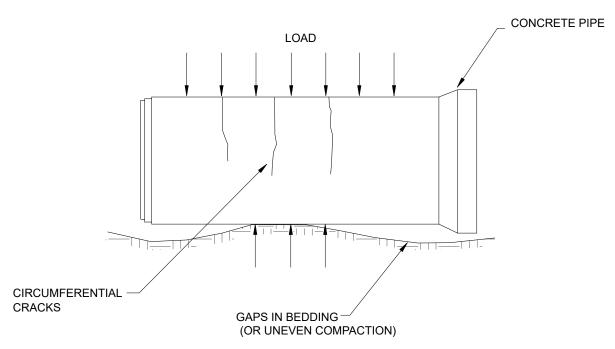
Figure F.12 BEAM FAILURE - UNEVEN SUPPORT ALONG THE PIPE

In this example there is uneven support; the pipe has limited contact with the trench bottom, typically near the centre of the pipe. Trench backfill and surface loads are exerted on the pipe, causing it to act as a cantilever beam. Circumferential cracking originates at the soffit and extends towards the spring line. Cracking is generally concentrated at midpoint of pipe and is often seen to propagate from the lifting hole in stormwater conduits.

- (a) Circumferential cracking originating at the soffit where the largest gap would be observed;
- (b) Infiltration and encrustation may be observed; and
- (c) Some spalling may be evident associated with the cracks.

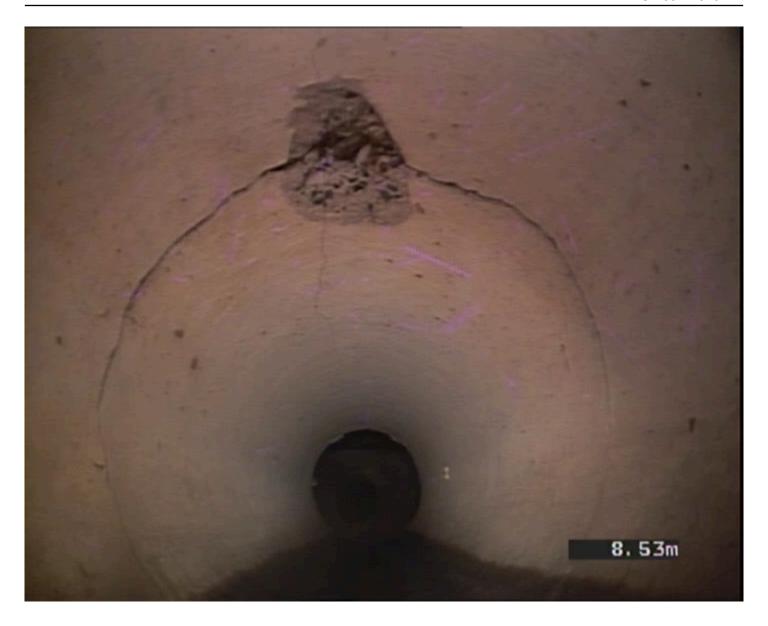
Figure F.13 EXAMPLE OF CIRCUMFERENTIAL CRACKING AS A RESULT OF UNEVEN SUPPORT ALONG THE PIPE

Figure F.13 provides an example of circumferential cracking originating from the soffit. Spalling is apparent at 12 o'clock.

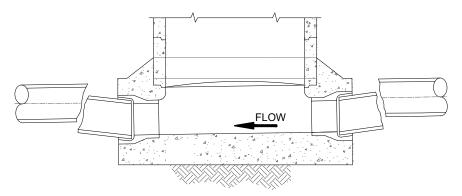
Figure F.14 SHEAR FAILURE PATTERN

When rigid pipes are partly restrained by a structure such as a pit, concrete encasement or maintenance hole, the pipe is effectively a cantilever. When backfill and surface loads are exerted on the pipe circumferential cracking may be initiated similar to <u>F2.3.2 Example 2</u>.

Cracking will change to a shear action if support for the embedded pipe in the structure or the 'free' pipe allows for differential movement. <u>Figure F.14</u> illustrates a defect that may be observed adjacent to maintenance structures or concrete encasement. In the scenario depicted the structure has settled relative the pipework.

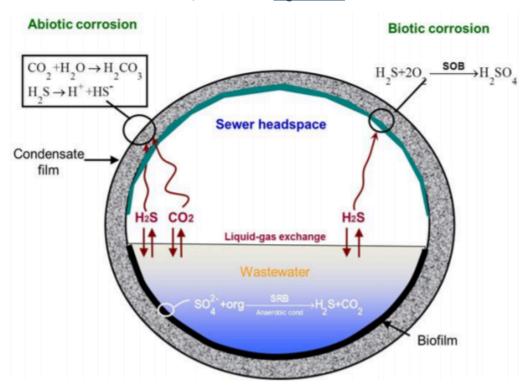
Figure F.15 MECHANISM OF CORROSION FROM SULPHURIC ACID

The anaerobic bacteria present on the walls of the pipe and structures oxidises the hydrogen sulphide dissolved in the moisture on the pipe walls and produces sulphuric acid. The acid gradually corrodes the cement-based matrix of concrete and asbestos cement above the usual water line, as shown in **Figure F.15**.

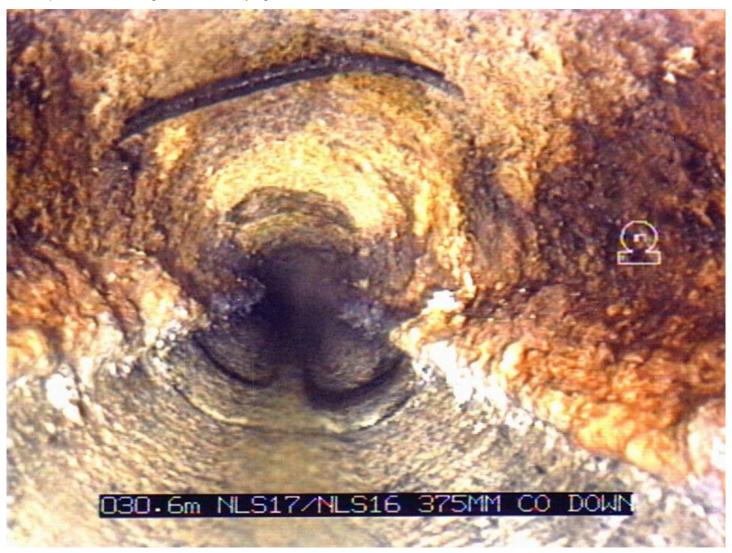
Figure F.16 EXAMPLE OF CORROSION IN A CONCRETE PIPE

Figure F.16shows a concrete pipe that has disintegrated completely above the normal water level. At the joint, a rubber ring is visible in the soffit. This is an indicator that the fabric of the conduit has completely disappeared. From 8 to 4 o'clock in the pipe are the skeletal remains of the concrete pipe in a thin veneer of corrosion by-products (in parts) over the surrounding soil. A 'veneer' of corrosion products will often be a feature in concrete pipes subject to H₂S corrosion, and its presence can disguise the underlying condition of the concrete.

This concrete sewer was on a steep grade and downstream of a rising main discharge point, which can influence the rate of corrosion in concrete sewer pipes.

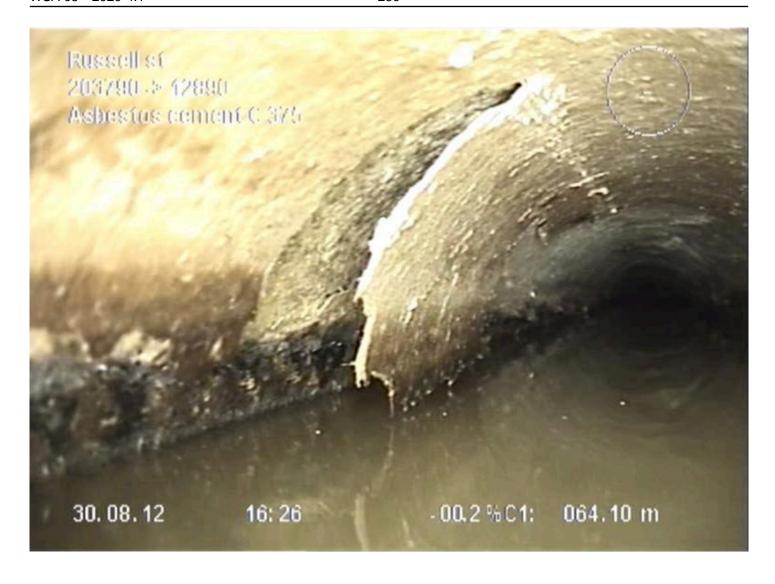
Figure F.17 EXAMPLE OF CORROSION IN AN ASBESTOS CEMENT PIPE

Corrosion of asbestos cement pipe has similar characteristics to concrete, but because of the binding effect of the asbestos fibres, the loss of fabric occurs through delamination as illustrated in <u>Figure F.17</u>.

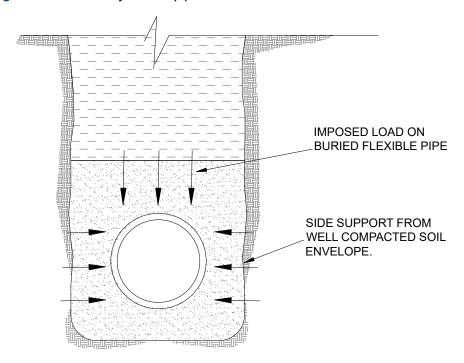
Where side support is poor due to inadequate embedment compaction and/or migration of fines from the trench wall into the embedment gravel, the resistance to horizontal outward movement is not activated and the pipe will lose its circular shape, as shown in **Figure F.18**. For many flexible pipes this will be a common issue.

Figure F.18 SUPPORT OF FLEXIBLE PIPES; a) adequate support and b) inadequate support resulting in deformation

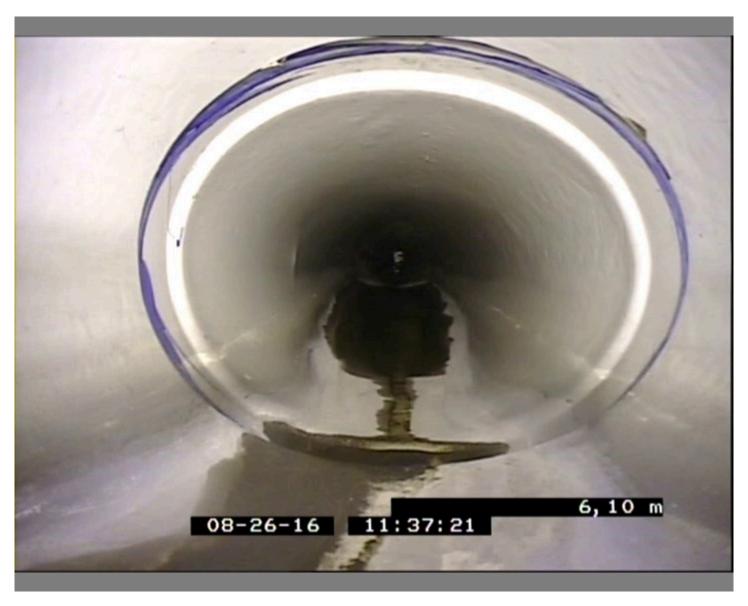
Significant deformation in 225 uPVC pipes is shown below. These examples are stormwater drains in private developments.

Figure F.19 A - EXAMPLES OF DEFORMATION IN uPVC PIPES

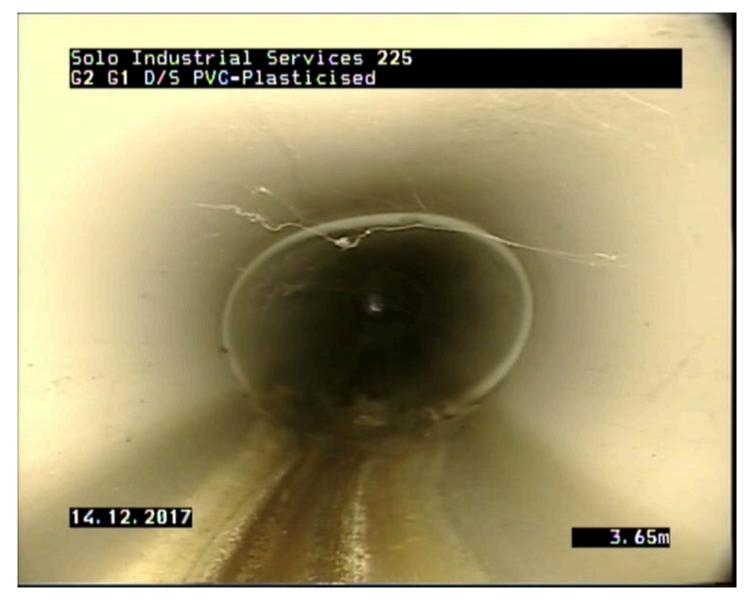
Figure F.19 B - EXAMPLES OF DEFORMATION IN uPVC PIPES

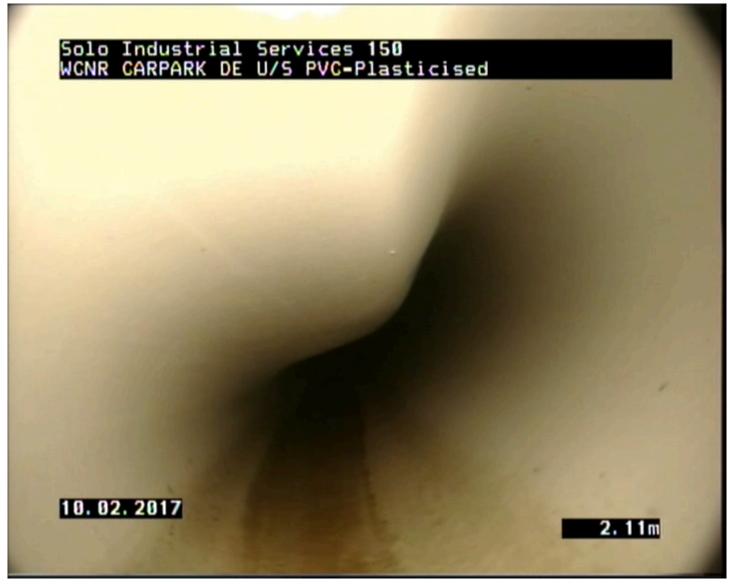
For plastics pipes creep contributes to deformation. Creep of plastics pipes occurs when the material is under constant stress and will allow further deformation to occur beyond the initial elastic response. The creep phenomenon is most noticeable when there are external concentrated loads, caused typically by an object like a boulder in the backfill or a load is imposed by the arrangement of fittings, where a local deformation will be manifested, as shown in **Figure F.20**.

Figure F.20 EXAMPLE OF CREEP AND DEFORMATION

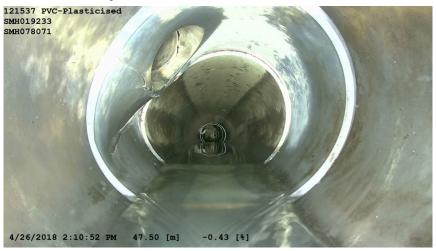
Although not common, cracking of plastics may also occur associated with these local deformations. <u>Figure F.21</u> shows deformation and cracking in the junction fitting. The lateral configuration incorporates a bend fitting off the junction branch and a vertical riser. The shear earth loading on the vertical riser may be the contributing cause of the deformation and cracking. This defect would be recorded as broken displaced in the main conduit, and the defective junction code would need to be applied for the defects occurring in the lateral.

Figure F.21 EXAMPLE OF DEFORMATION AND CRACKING

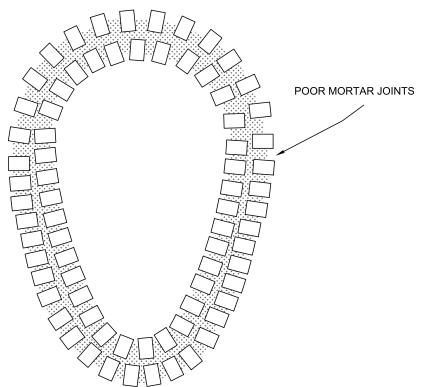
The conduit has poor mortar joints, attributable to the original construction and/or mortar loss, as the mortar deteriorates through corrosion and erosion.

Figure F.22 STAGE 1 LOSS OF SIDE SUPPORT

- (a) Mortar loss; and
- (b) Signs of infiltration.

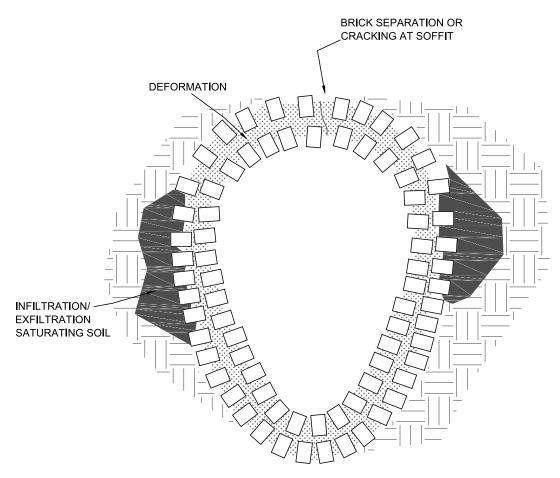
The loss of mortar in some joints particularly at mid-height allows for infiltration. Cycles of hydraulic overloading (surcharging) cause exfiltration and infiltration, where the surrounding soil becomes saturated and then allows ingress of soil when surcharging subsides. This reduces the side support, as shown in <u>Figure F.23</u>, allowing outward movement of the bricks into the lower density soil. As the sides move out, the crown tends to drop with brick separation and or cracking appearing at the soffit.

Figure F.23 STAGE 2 LOSS OF SIDE SUPPORT

- (a) Deformation;
- (b) Brick separation or cracking at the soffit; and
- (c) Closing of the gap between brick courses at the haunches where mortar has been lost.

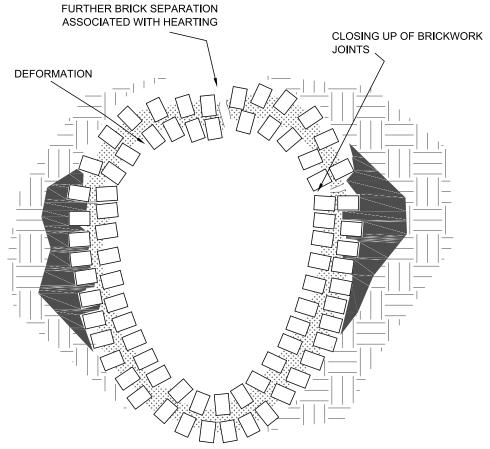
There is continuing vertical deformation as the side support diminishes, and the structure moves outward at mid-height. Brick separation increases in the soffit with the structure forming a 'heart' shape, as shown in <u>Figure F.24</u>. There may be loss of bricks from the soffit and spalling at the haunches. Collapse is imminent without remedial action.

Figure F.24 STAGE 3 LOSS OF SIDE SUPPORT

- (a) Deformation;
- (b) Pronounced brick separation at the soffit associated with hearting;
- (c) Closing up of brickwork joints in the haunches;
- (d) Possible spalling; and
- (e) Possible loss of bricks from the crown.

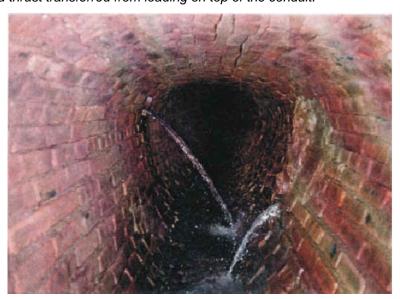
<u>Figure F.25</u> shows an example of the loss of side support associated with the loss of mortar. However, the same progression of structural deterioration may occur without significant loss of mortar if the soil surrounding the conduit is unable to resist the outward thrust transferred from loading on top of the conduit.

Figure F.25 EXAMPLE OF LOSS OF SIDE SUPPORT

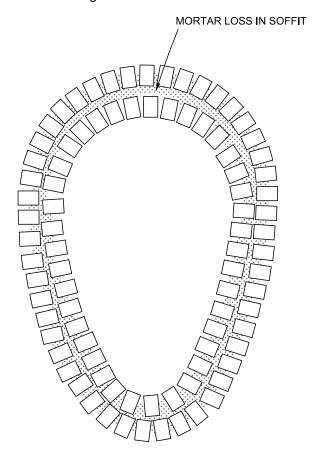
The conduit has poor mortar joints, attributable to the original construction and/or mortar loss, as the mortar deteriorates through corrosion and erosion. This is occurring predominantly in the soffit. The side support is retained throughout, with no outward movement of the structure at mid-height.

Figure F.26 STAGE 1 LOSS OF BRICKS AT SOFFIT

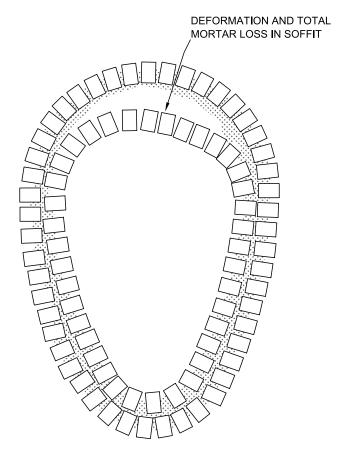
There is loss of mortar between bricks in soffit, which allow joints to close and the inner ring of bricks at soffit to separate from outer ring, as shown in <u>Figure F.27</u>.

Figure F.27 STAGE 2 LOSS OF BRICKS AT THE SOFFIT

- (a) Total mortar loss apparent in soffit;
- (b) Deformation limited to soffit bricks; and
- (c) Some displaced bricks in the soffit.

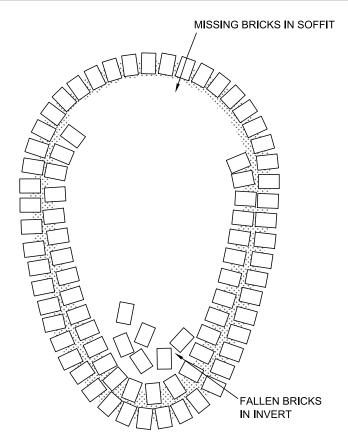
There is a loss of compressive load on inner ring of bricks in crown, which allows bricks to be dislodged and fall, as shown in <u>Figure F.28</u>. This causes the progressive collapse of the inner ring.

Figure F.28 STAGE 3 LOSS OF BRICKS AT SOFFIT

- (a) Missing bricks in soffit, bricks in invert; and
- (b) Structural deterioration may occur in single ring conduits leaving soil visible if the surrounding ground is a stiff cohesive clay.

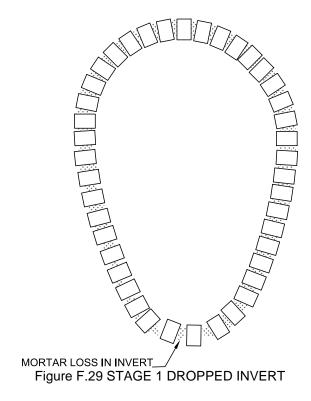
Loss of mortar in the invert allows infiltration or exfiltration, and possibly ingress of soil.

- (a) Mortar loss in invert, but may be obscured by water level; and
- (b) Infiltration, exfiltration and ingress of soil, but may be difficult to observe.

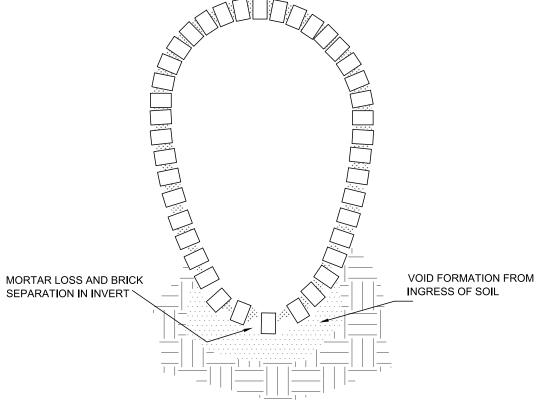
Ingress of soil increases through gaps in the invert as a result of lost mortar. This causes voids to form below the structures' invert.

Figure F.30 STAGE 2 DROPPED INVERT

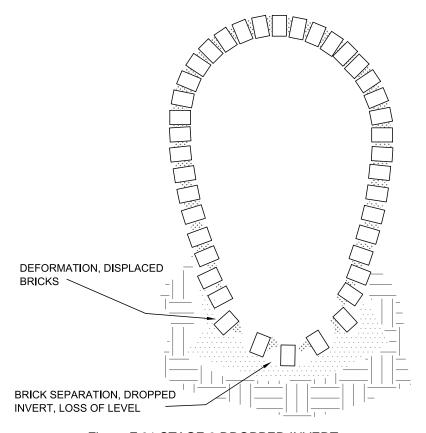
Loss of support below the structure allows the invert to drop into the void. The side walls may also drop, or they may be held in place by mortar or friction.

Figure F.31 STAGE 3 DROPPED INVERT

- (a) Brick separation around water line;
- (b) Dropped invert;
- (c) Missing bricks in invert;
- (d) Displaced bricks in walls;
- (e) Deformation; and
- (f) Loss of level.

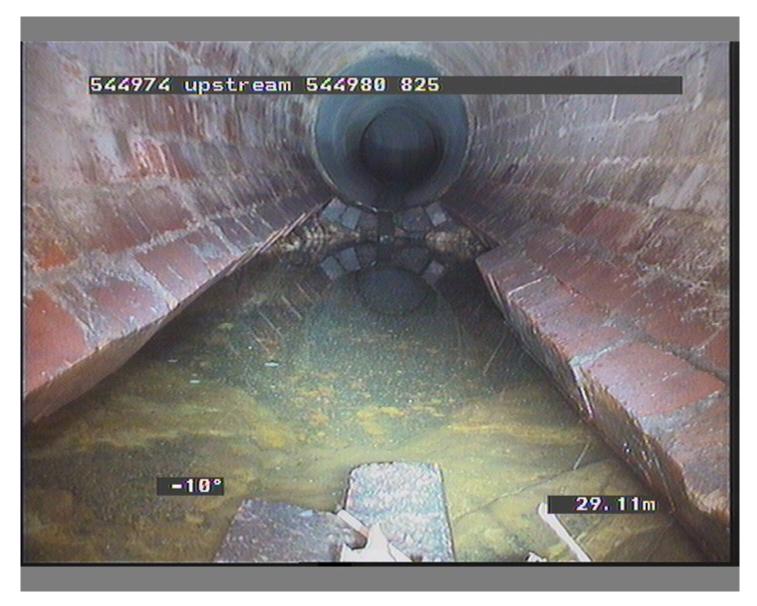
Figure F.32 EXAMPLE OF A DROPPED INVERT

An example of a dropped invert is shown in Figure F.32.

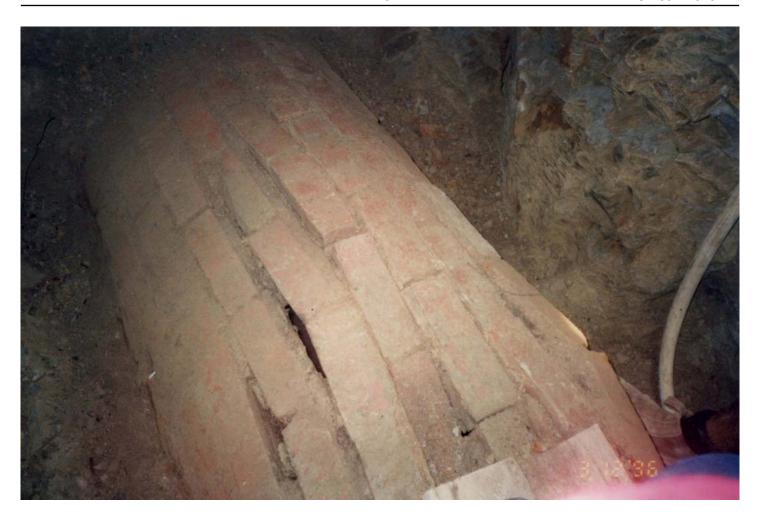
<u>Figure F.33</u> depicts photographs of a shallow brick stormwater conduit where the bricks have been displaced outwards as if the conduit has buckled under the compressive load imposed by ceramic growth.

Figure F.33 A - EXAMPLES OF BRICK DISPLACEMENT

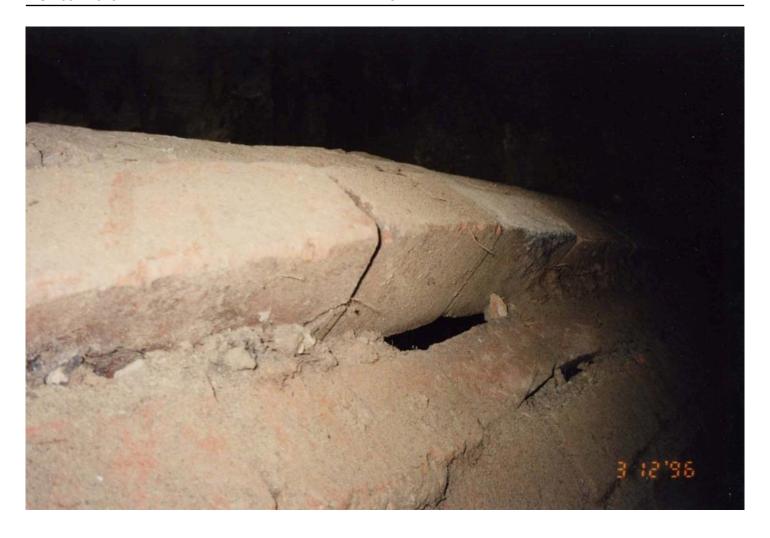
Figure F.33 B - EXMAPLES OF BRIKCK DISPLACEMENT

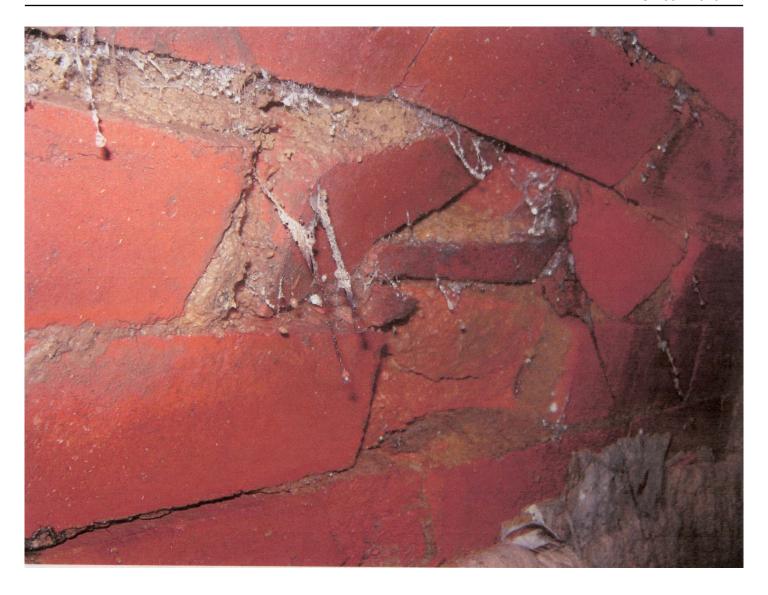
<u>Figure F.34</u> illustrates the relieving of ceramic growth stresses by the displacement of bricks along with spalling or crushing of some bricks in the vicinity. These defects are likely to be observed in sections where zones of high stress have developed.

Figure F.34 EXAMPLE OF BRICK DISPLACEMENT WITH SPALLING AND CRACKING

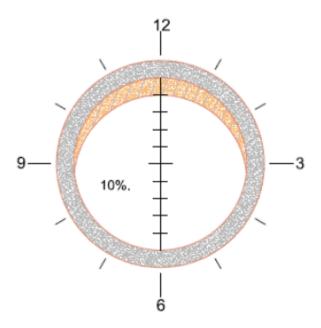
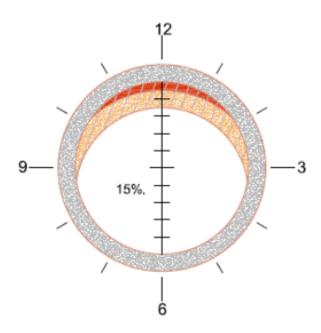
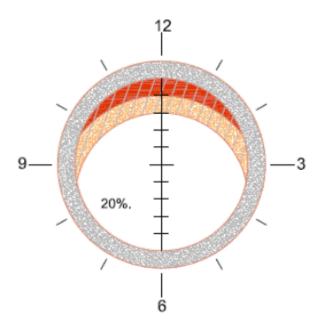
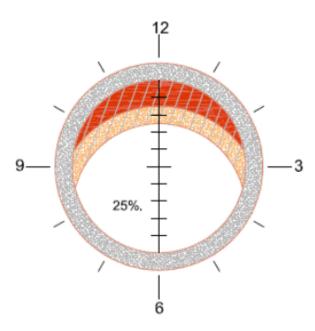
The following figures provide a guide to estimating the magnitude of vertical/shear displacement of a rigid **conduit** at a failed joint or where circumferential cracking has allowed the 'ends' of the pipe to move significantly from alignment. The feature will be described as broken displaced BD with Quantification 2 recording the magnitude of displacement to the nearest 5%.

Where shear displacement is associated with a joint it should be recorded as a displaced joint, radial displacement (refer to <u>2.7.5.1 Displaced joint—JD</u>). Further, where radial displacement at a joint is such that a void or soil is visible, the defect is recorded as broken displaced or collapsed depending on the magnitude of the displacement. (Refer to Note 7 of <u>2.7.5.1 Displaced joint—JD</u>).

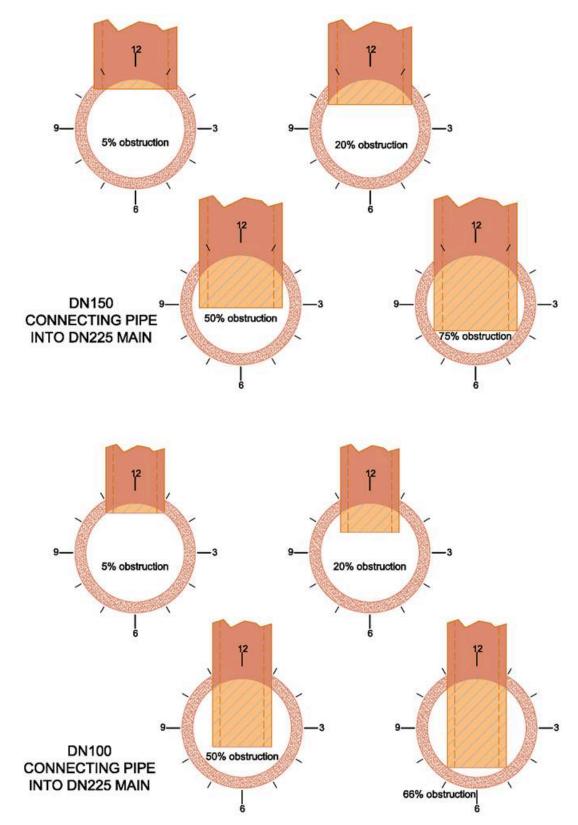
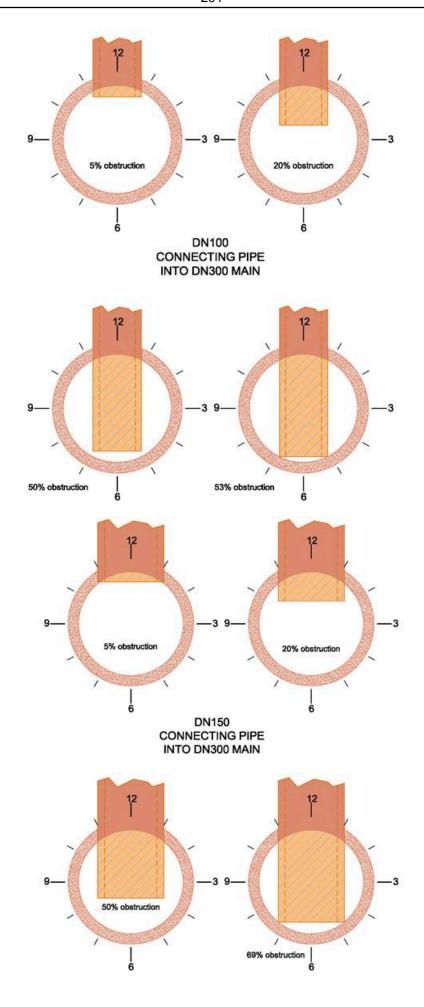
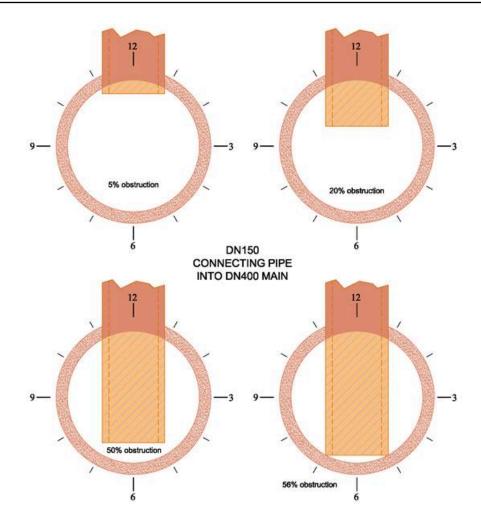
11.2 ESTIMATING MAGNITUDE OF INTRUSION (OBSTRUCTION) FROM INTRUDING CONNECTION (CI)

The following figures provide a guide to estimating the magnitude of intrusion (obstruction) where a connecting **conduit** is projecting into the conduit being inspected. The applicable code is Intruding Connection - **CI**.

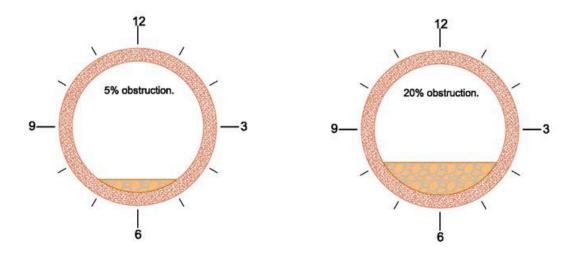
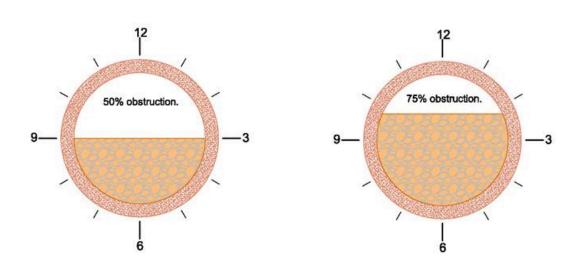
11.3 ESTIMATING OBSTRUCTION FROM DEPOSITS IN THE INVERT (DE)

The following figures provide a guide to estimating the magnitude of an obstruction from deposits in the invert measured as a percentage reduction in cross sectional area of the **conduit**. The applicable codes are **DEC**, **DER**, **DES** and maybe **DEZ**.

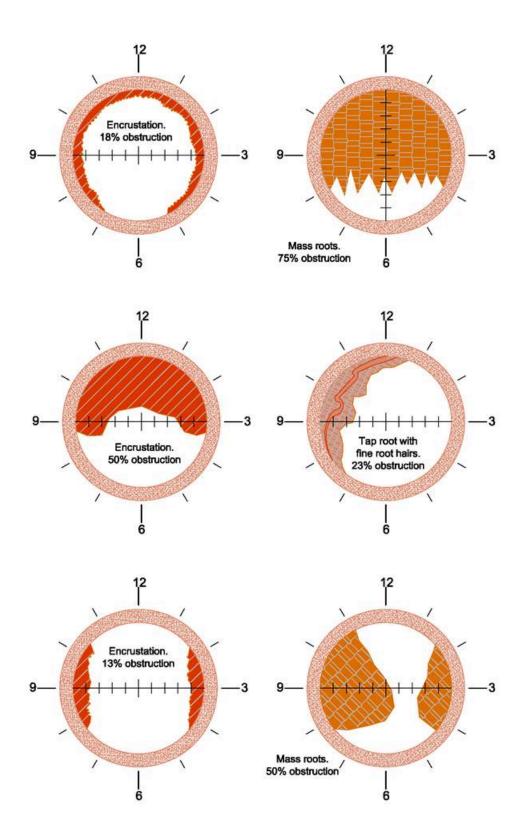
11.4 ESTIMATING OBSTRUCTION FROM DEPOSITS ON WALLS AND ROOTS (DE_R)

The following figures provide a guide to estimating the magnitude of an obstruction from deposits (encrustation, fouling, grease) on the walls and roots measured as a percentage reduction in cross sectional area of the **conduit**. The applicable codes are **DEE**, **DEF**, **DEW**, **RM** and **RT**.

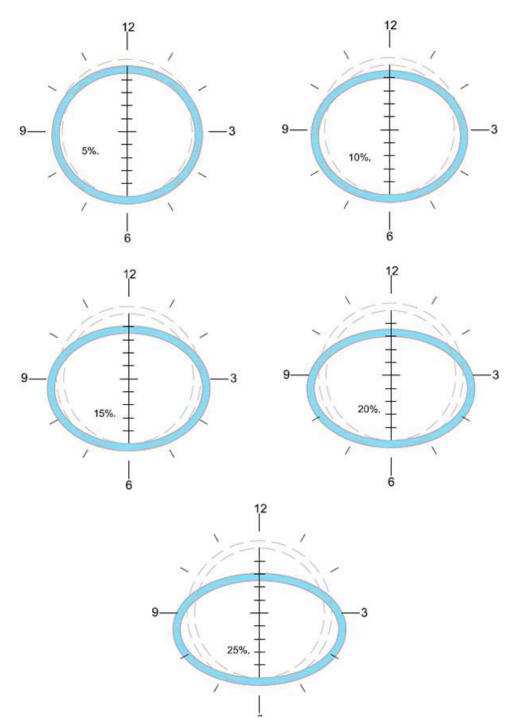
I1.5 ESTIMATING DEFORMATION (D)

'Deformation' of a rigid pipe will also be substantially different, as several hinges have to form to allow movement. Nevertheless, estimation of the magnitude of deformation will be similar and the diagrams may be used for estimating of deformation for all pipes.

The applicable code is **DV**.

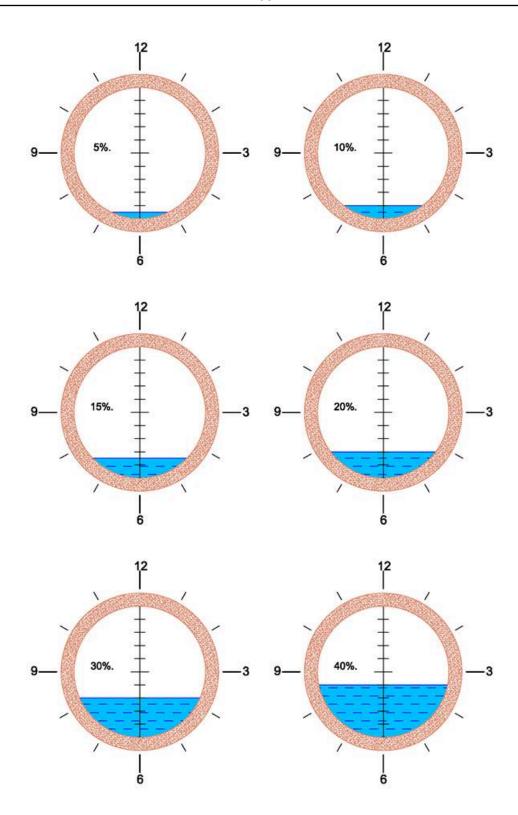
I1.6 ESTIMATING WATER LEVEL (WL)

The following figures provide a guide to estimating the water level of flow and flow in connecting $\underline{\text{conduit}}$. Applicable codes include $\underline{\text{WL}}$ and $\underline{\text{IF}}$.

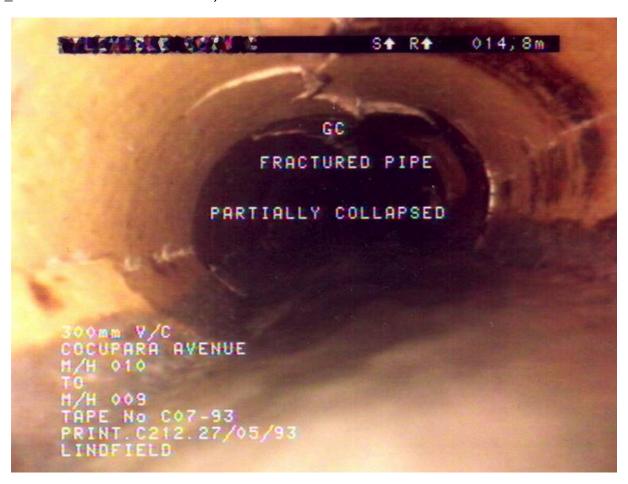
12.1 BD_DV - BREAKING DISPLACED, DEFORMATION VERTICAL

Code	Ch1	Ch2	Q1	Q2	Circ	loc'n	Joint	Long loc'n	Cont	Remarks
В	D		900		12	12				
D	V		15		12

The screen captured general comment in the photograph is misleading. The 'fracturing' is not important at this location and 'partially collapsed', although conveying the appearance of the structural failure and progression towards collapse, conflicts with the codes which do not record 'partial collapse'.

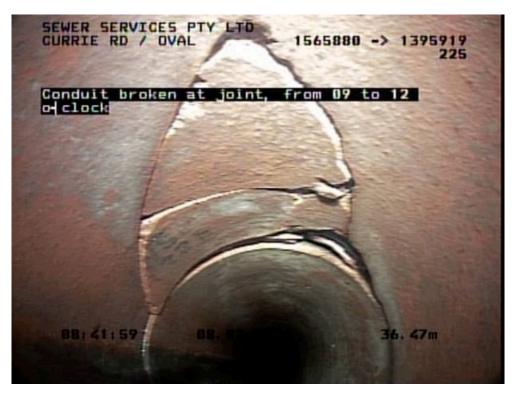
12.2 BM - BREAKING MISSING

Code	Ch1	Ch2	Q1	Q2	Circ	loc'n	Joint	Long loc'n	Cont	Remarks
В	М		300		9	1	J

This VC conduit is breaking from **9 to 1** o'clock adjacent to the joint for a distance of about 300 mm. Although most pieces are still present there is an area with some pieces missing and as such the broken missing (**B-M**) observation is the most appropriate.

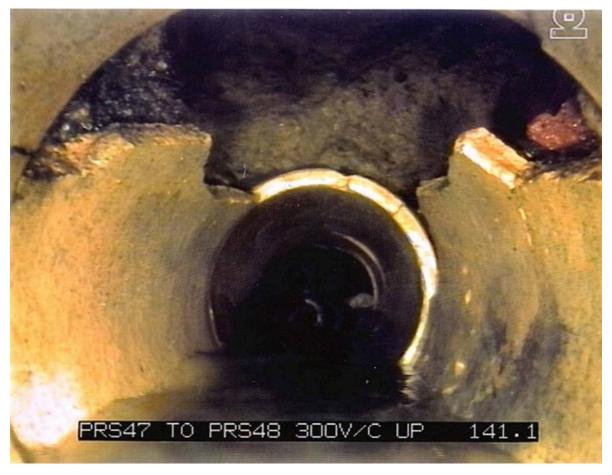
12.3 BM VV - BREAKING MISSING, VOID VISIBLE

Code	Ch1	Ch2	Q1	Q2	Circ	loc'n	Joint	Long loc'n	Cont	Remarks
В	М		600		10	2				
vv			Α		10	2

Further investigation may be undertaken to determine the exact extent of the void using laser profiling or ground penetrating radar.

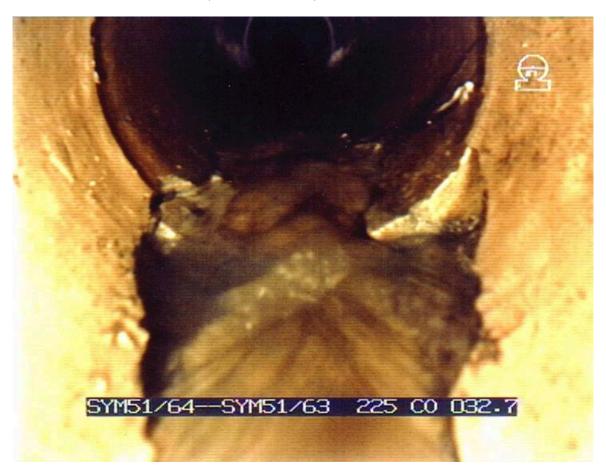
12.4 BM_VV_EX - BREAKING MISSING, VOID VISIBLE, EXFILTRATION

Code	Ch1	Ch2	Q1	Q2	Circ	loc'n	Joint	Long loc'n	Cont	Remarks
В	М		400		4	7	J			
vv			Α		6	7				
EX					4	7

The joint field is not completed for **VV** and **EX** observations because these features are not specifically 'influenced in magnitude or nature by the presence of a conduit joint'.

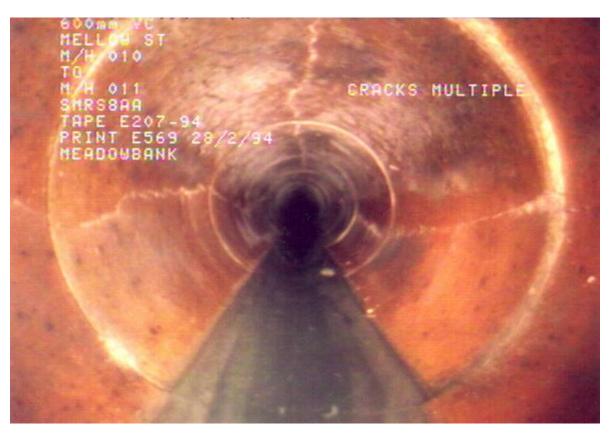
12.5 CL - CRACKING LONGITUDINAL

Code	Ch1	Ch2	Q1	Q2	Circ	loc'n	Joint	Long loc'n	Cont	Remarks
С	L		0.5		9				S1	
С	L		1		12	12			S2	
С	L		0.5		3				S3	
С	L		1		6				S4

Since the longitudinal cracking clearly continues for the next two pipes or more, report the continuous start codes for **each** crack.

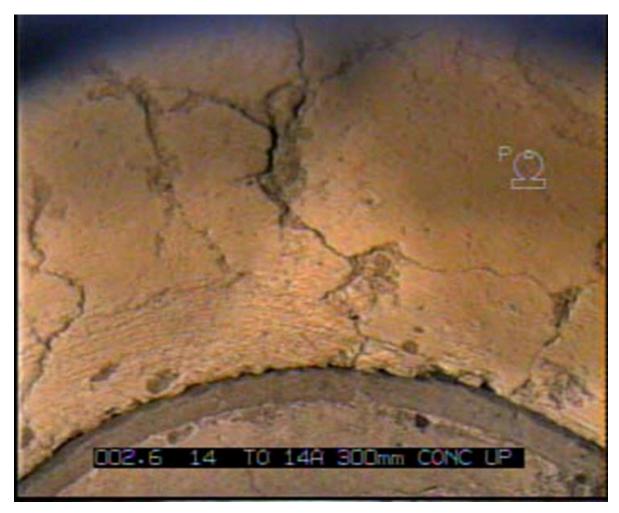
12.6 CM - CRACKING MULTIPLE

Code	Ch1	Ch2	Q1	Q2	Circ	loc'n	Joint	Long loc'n	Cont	Remarks
С	М		2		11	1	J

It is not clear what the cause of the damage is, but it may be from poor handling during transportation to site, from excessive external loading through poor installation or site management practices.

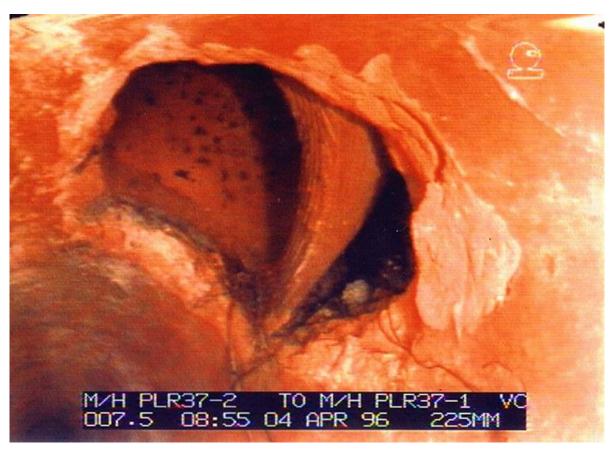
12.7 CNO_CXP_VV_RF - CONNECTION OPEN, DEFECTIVE CONNECTION INCORRECT POSITION, VOID VISIBLE, ROOTS FINE

Code	Ch1	Ch2	Q1	Q2	Circ	loc'n	Joint	Long loc'n	Cont	Remarks
CN	0		100		1					
сх	Р			50						
vv			Α		2	3				
R	F				3

Fine roots (RF) are also evident in the connecting pipe at 6 o'clock and through the void.

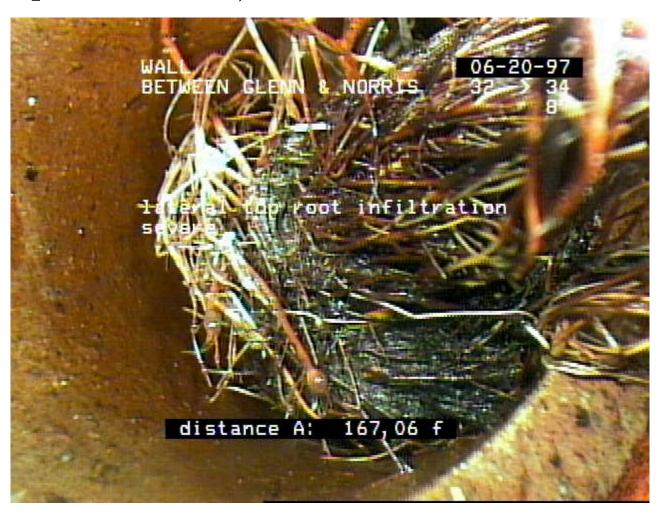
12.8 CNO_CXSR - CONNECTION OPEN, DEFECTIVE CONNECTION SOME ROOTS

Code	Ch1	Ch2	Q1	Q2	Circ	loc'n	Joint	Long loc'n	Cont	Remarks
CN	0		A		Α					
сх	SR		A	Α
