CONDUIT INSPECTION REPORTING CODE OF AUSTRALIA

Version 4.1

WSA 05-2020

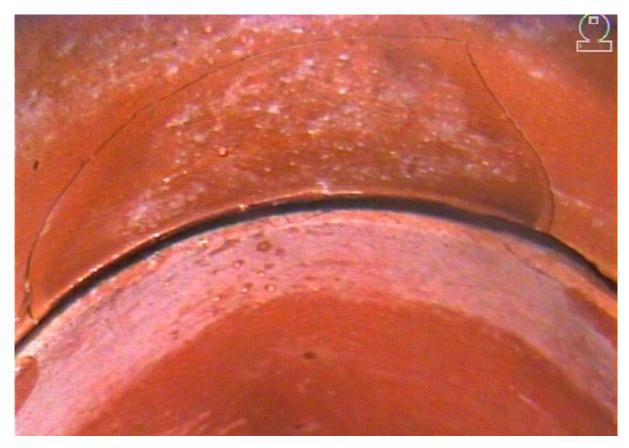
12.9 CS - CRACKING SIMPLE

Code	Ch1	Ch2	Q1	Q2	Circ loc'n		Joint	Long loc'n	Cont	Remarks
С	s		0.5		11	1	J

This defect is the classic simple crack (**C-S**) in a VC sewer where the crack appears to start and return to the same joint between **11 and 1** o'clock. Since the defect is associated with the joint, record **J** in the joint field. The crack width is estimated at **0.5** mm.

The cracking in this case is one continuous crack with no branches. In other examples the crack may branch to create a few separate pieces of pipe.

This type of cracking will most commonly occur on the downstream side of joints as it is associated with damage of the VC pipe socket.

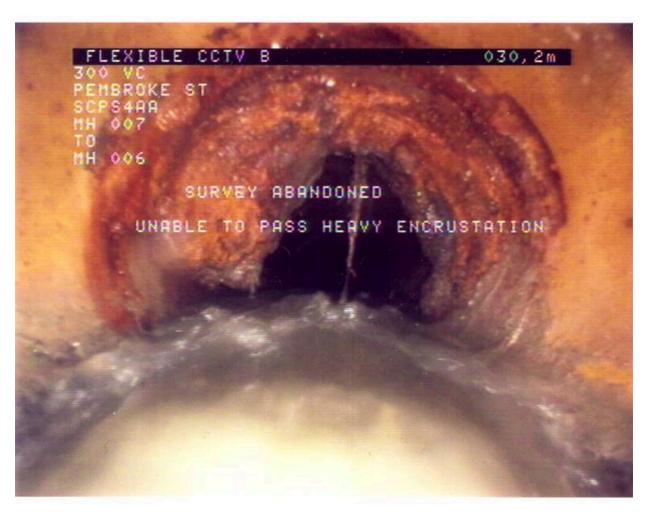
12.10 DEE SAOB - DEPOSITS ENCRUSTATION WALLS, SURVEY ABANDONED OBSTRUCTION

Code	Ch1	Ch2	Q1	Q2	Circ	loc'n	Joint	Long loc'n	Cont	Remarks
DE	E		50		8	4				
SA	ОВ									Heavy encrustation

The deposits on the walls and soffit of the conduit above the water line can be classified as encrustation (**DE-E**) from **8** to **4** o'clock. It is the result of water seeping through a defect (which cannot be determined from this photograph) leaving an accumulation of minerals on the wall of the conduit. The build-up of encrustation, which reduces the cross section is reported as **50%** obstruction.

The inspection was abandoned (**SA-OB**) due to the obstruction caused by the encrustation, which is reported in the remarks field. Any continuous codes should be closed before coding SAOB.

The reflected light on the encrustation is a sign of infiltration. Encrustation of this type will often have seepage, dripping or running infiltration associated with it. In this case it is not necessary to code this feature given that conduit should be cleaned, after which the extent of infiltration and other defects will become clearer.

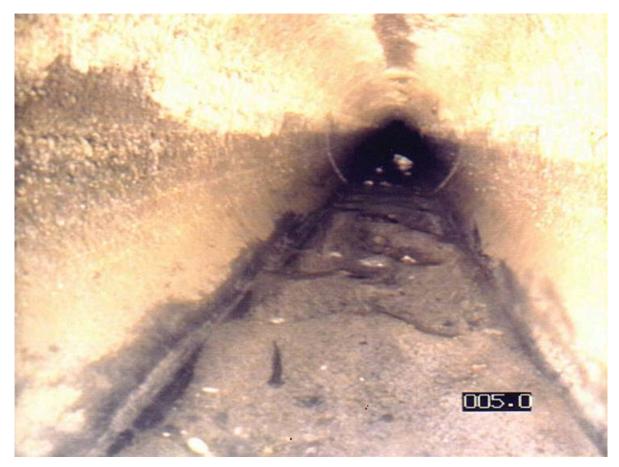
12.11 DES - DEPOSITS FINE SEDIMENT (EXAMPLE 1)

Code	Ch1	Ch2	Q1	Q2	Circ loc'n		Joint	Long loc'n	Cont	Remarks
DE	s		10		5	7			S1

Sand has been deposited in the invert of this conduit (**DE-S**). The obstruction caused by the sand, which is estimated to reduce the cross sectional area available by **10%**. The sand is a continuous feature (**S1**).

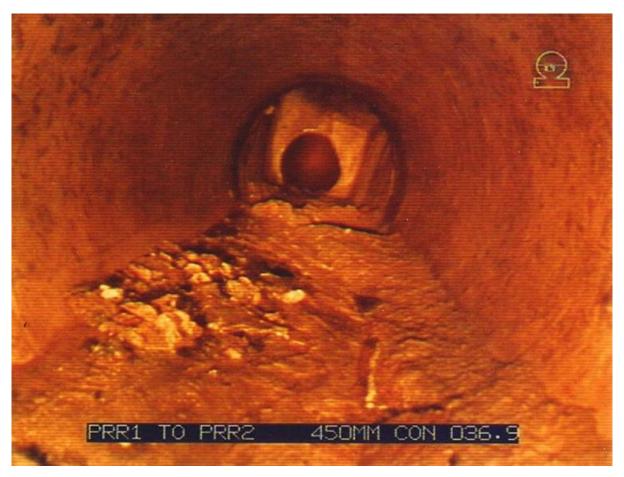
12.12 DES - DEPOSITS FINE SEDIMENT (EXAMPLE 2)

Code	Ch1	Ch2	Q1	Q2	Circ	loc'n	Joint	Long loc'n	Cont	Remarks
DE	S		10		5	7			S1	Some rubble at 8 o'clock

Sand with some rubble has been deposited in the invert of this conduit (**DE-S**). The obstruction caused by the deposits, which are estimated to reduce the cross-sectional area available by **10%**. The deposits are a continuous feature (**S1**).

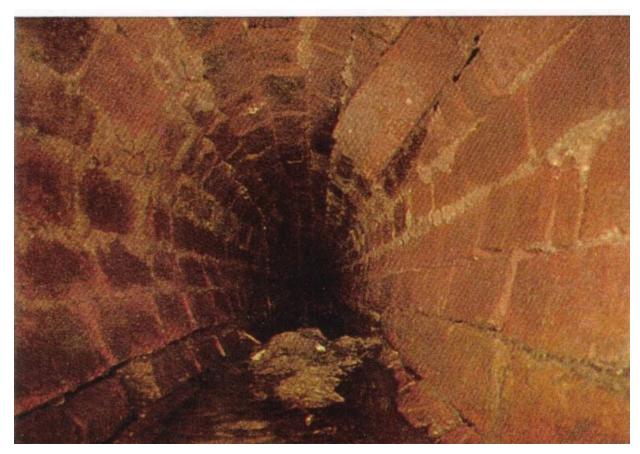
I2.13 DMU_DH_MUS_DER - DISPLACED MASONRY UNITS MOVED INWARDS, DEFORMATION HORIZONTAL, MASONRY UNIT SEPARATION, DEPOSITS COARSE SEDIMENT INVERT

Code	Ch1	Ch2	Q1	Q2	Circ	loc'n	Joint	Long loc'n	Cont	Remarks
DMU	ı		70		1					
D	н		5		3	5				
MUS			10		8				S1	
DE	R		10		5	7				Rags present

There are several defects in this brick oviform (ovoid) conduit to report.

The separated jointing (**MUS**) at **8** o'clock, which is reported as **10 mm** in Q1 and also as a continuous feature (**S1**). The same defect is suspected at 5 o'clock, but the position of the camera and the debris in the invert does not allow its confirmation. If further investigation also revealed similar brick separation at 4 o'clock, it would be appropriate to code the defect as a dropped invert (DI).

The debris in the invert appears is coarse sediment and rags, which has been coded **DE-R** with a comment in the remarks field. The debris reduces the cross section and is reported as **10%**.

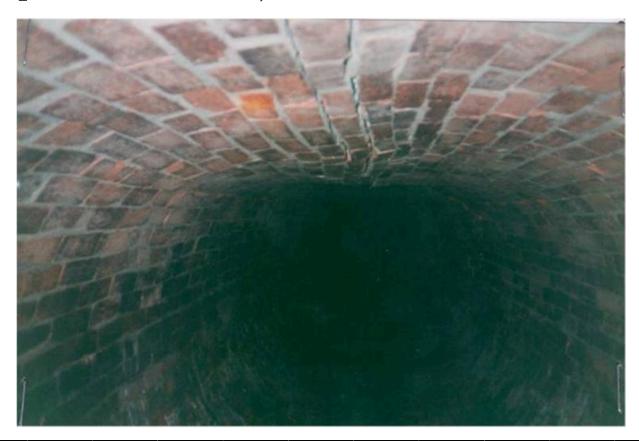
12.14 DV MUS - DEFORMATION VERTICAL, MASONRY UNIT SEPARATION

Code	Ch1	Ch2	Q1	Q2	Circ	loc'n	Joint	Long loc'n	Cont	Remarks
D	V		10		12				Α	
MUS			10		12				A	Separation along mortar joints on each side of the central brick course

The brick courses at the soffit of this oviform (ovoid) brick conduit have deformed vertically (**D-V**) and is reported as **10%** deformation. To permit such a deformation the walls must have moved outwards slightly due to loss of ground (side-wall) support. The resultant feature is sometimes referred to as 'hearting' failure of brick conduits.

As far as we can see the deformation is continuous in both directions so 'A' (applicable) is noted in the continuous field.

Brick separation (**MUS**) at the crown (**12** o'clock) is also evident. Separation along mortar joints on each side of the central brick course is reported in the remarks. The typical width of the separation is reported as **10 mm** separation. The separation is also continuous.

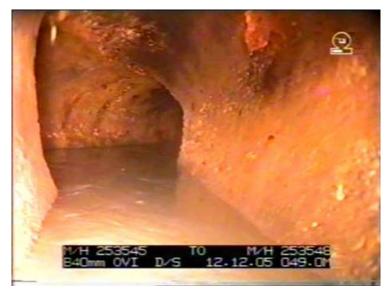
12.15 FHC - FINISH NODE MAJOR CONNECTION

(Code	Ch1	Ch2	Q1	Q2	Circ lo	oc'n	Joint	Long loc'n	Cont	Remarks
	FH	С		A							Entry to 1295 oviform

See also **12.15 FHC - Finish node major connection** for the end of the curve.

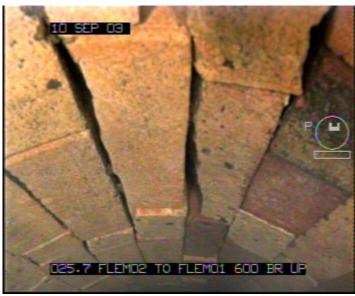
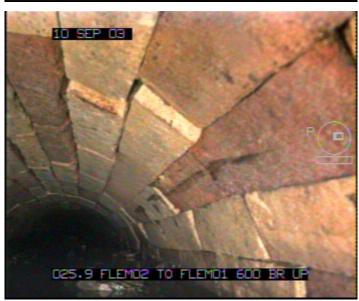
12.16 GPFU_GC - GENERAL PHOTOGRAPH, GENERAL COMMENT

Code	Ch1	Ch2	Q1	Q2	Circ	loc'n	Joint	Long loc'n	Cont	Remarks
GP	F	U								Brick conduit constructed without mortar
GC									A	Brick conduit constructed without mortar

Nevertheless, the total absence of mortar between the bricks should be reported using the general photograph (**GP**) and the general comment (**GC**) codes. The absence of mortar should not be coded as a defect in this instance.

The feature appears to be continuous and probably started some distance before 25.7 m so 'A' (applicable) has been recorded in the continuous field. The oddly shaped brick at 12 o'clock at distance 25.7 m is probably from rough cutting to get it to fit as a keystone and not from damage.

Some bricks may have moved inwards, or they may have been constructed that way. Further investigation would be required to confirm before reporting this feature.

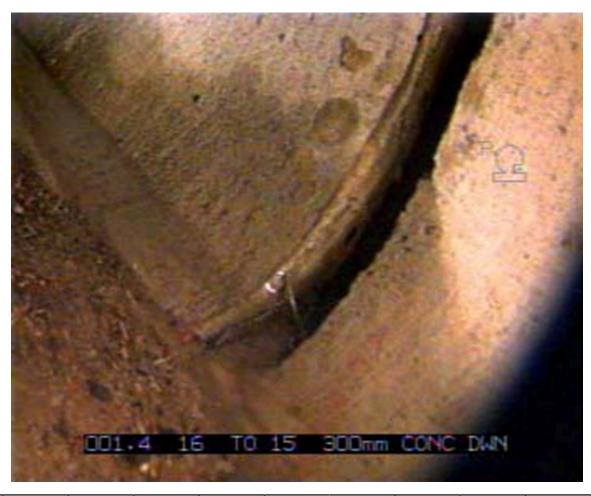
12.17 JDL - DISPLACED JOINT LONGITUDINAL

Code	Ch1	Ch2	Q1	Q2	Circ	Circ loc'n		Long loc'n	Cont	Remarks
JD	L		30				J	1.4

Close examination is required to determine the integrity of the joint.

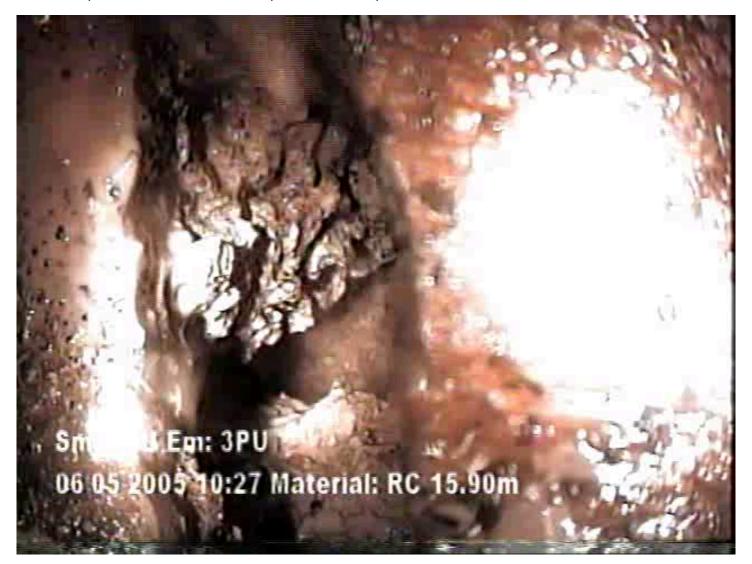
I2.18 JDL_ING_IR_VV_GCU - DISPLACED JOINT LONGITUDINAL, INGRESS OF SOIL, INFILTRATION DRIPPING, INFILTRATION RUNNING, VOID VISIBLE, GENERAL COMMENT URGENT

Code	Ch1	Ch2	Q1	Q2	Circ	loc'n	Joint	Long loc'n	Cont	Remarks
JD	L		70				J			
ING	F				11		J			Small lumps of clay observed falling
ı	R				11		J			
vv			Α		9	3	J

The multiple observations at this location could have been missed if the operator had not examined the longitudinal joint displacement (**JD-L**) in detail. The displacement is estimated to be **70** mm. The joint appears to be a butt joint with no collar or socket visible. Alternatively the socket may have been broken and dislodged.

Ingress of soil (ING-F), probably clay, at a joint (J) and associated with an infiltration runner (I-R) has been recorded separately.

Although soil is visible (SV) through the joint, void visible (**VV**) is reported as it is the more serious defect. It is not possible to estimate the void dimensions, which may not be relevant given the active nature of void formation.

The active ingress of soil and the growing void outside the conduit may present a substantial risk for the asset owner and should be reported as soon as possible by the operator, as well as using the **GC-U** code to alert the asset owner.

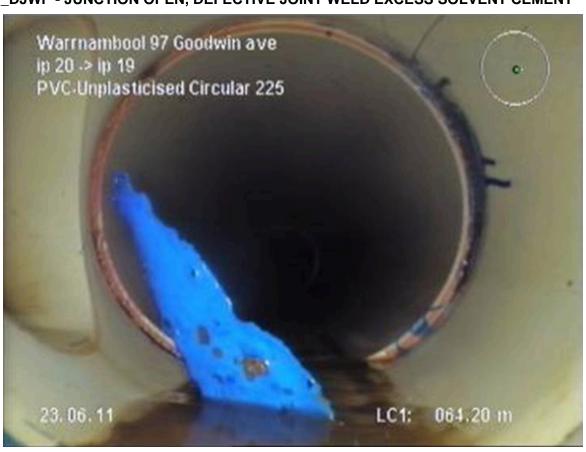
12.19 JNO DJWP - JUNCTION OPEN, DEFECTIVE JOINT WELD EXCESS SOLVENT CEMENT

Code	Ch1	Ch2	Q1	Q2	Circ loc'n		Joint	Long loc'n	Cont	Remarks
JN	O		150		9			64.2		
DJW	P				6			64.2		150 mm of hardened solvent flap is a

The solvent cement joint in the PVC-U pipe has been made with excess solvent applied. This has hardened and detached from the conduit to form a flap that could initiate a blockage and is reported as (**DJW_P**). A 150 mm open PVC-U junction (**JN-O**) is also reported.

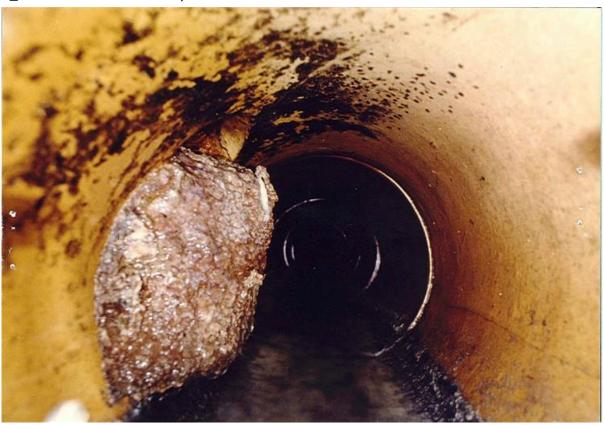
12.20 JNO_JXB - JUNCTION OPEN, DEFECTIVE JUNCTION BLOCKED

Code	Ch1	Ch2	Q1	Q2	Circ	loc'n	Joint	Long loc'n	Cont	Remarks
JN	0		100		9			Α		Assumed open
JX	В		80	20	9			A		Lateral blocked with unidentifiable mass and impacting on main sewer

The junction is assumed to be open.

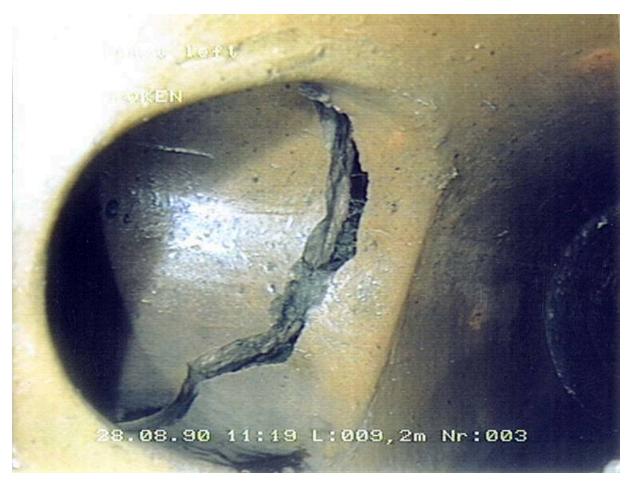
12.21 JNO_JXJC - JUNCTION OPEN, DEFECTIVE JUNCTION CRACKED

Code	Ch1	Ch2	Q1	Q2	Circ	loc'n	Joint	Long loc'n	Cont	Remarks
JN	O		150		9			9.2		
JX	JC				9			9.2		Repair required

The junction has a large circumferential crack near the joint with the main part of the fitting (JX-JC).

If this junction was below the water table or subjected to surcharge conditions for periods of its operation, infiltration and/or soil entry and/or exfiltration could occur. Depending on the location of the sewer, e.g. in an environmentally sensitive area, a remark suggesting that 'repair required' could be warranted.

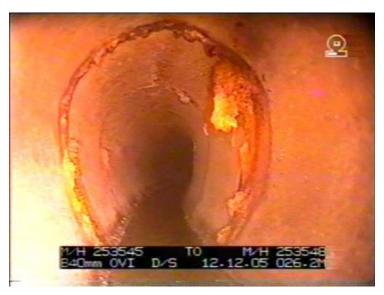
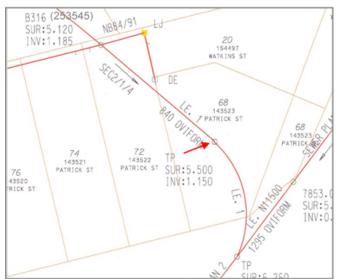
12.22 LR DEE - LINE OF CONDUIT DEVIATES RIGHT, DEPOSITS ENCRUSTATION WALL

Code	Ch1	Ch2	Q1	Q2	Circ	loc'n	Joint	Long loc'n	Cont	Remarks
L	R								S1	
DE	E		10		7	5			J

Also see 12.22 for the start of the curve of the 840 mm oviform sewer.

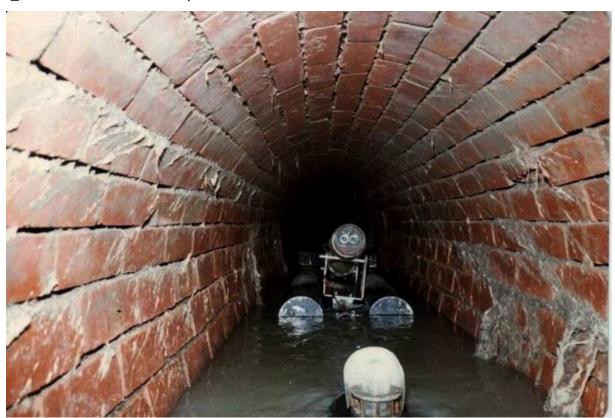
12.23 MM MM - MISSING MORTAR, MISSING MORTAR SUSPECTED

Code	Ch1	Ch2	Q1	Q2	Circ loc'n		Joint	Long loc'n	Cont	Remarks
ММ			20		8	4		Α	S1	
ММ					4	8		A	S2	Missing mortar below water line is highly likely. Further investigation at low flow to confirm suggested.

The brick conduit appears to be in reasonably good condition except that there appears to be some loss of mortar (MM) which is continuous and estimated at (20mm) depth of mortar loss between 8 and 4 o'clock.

It is likely that the mortar missing defect continues below the water level but that cannot be reported as observed. There are two options to report a likely defect that cannot be directly observed.

In this example it has been reported as **MM** between **4 and 8** o'clock with a remark suggesting further investigation. The benefit of this approach is that the suspected defect will contribute a score to the condition grading.

The alternative approach is to note that the missing mortar may exist under the water in the remarks (in the first observation) or as a General Comment (GC). However, either of these options will not generate a score for the underwater defect.

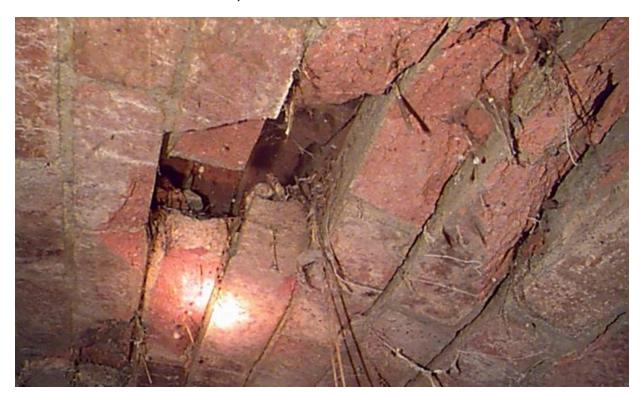
I2.24 MMUV_SOS_RF - MISSING MASONRY UNIT ANOTHER LAYER VISIBLE, MASONRY VISIBLE, SURFACE DAMAGE OTHER SPALLING, ROOTS FINE

Code	Ch1	Ch2	Q1	Q2	Circ loc'n		Joint	Long loc'n	Cont	Remarks
MMU	V		400		1					
so	S				1					
R	F				1	2

There are missing bricks at 1 o'clock in this brick conduit, which has another layer of bricks (MMU-V) behind the missing bricks.

Also associated with the missing bricks is spalling of the adjacent brickwork (SO-S).

The subject area of this photograph appears to be one of high compressive stresses that have contributed to the loss of bricks as well as the spalling of surrounding brickwork.

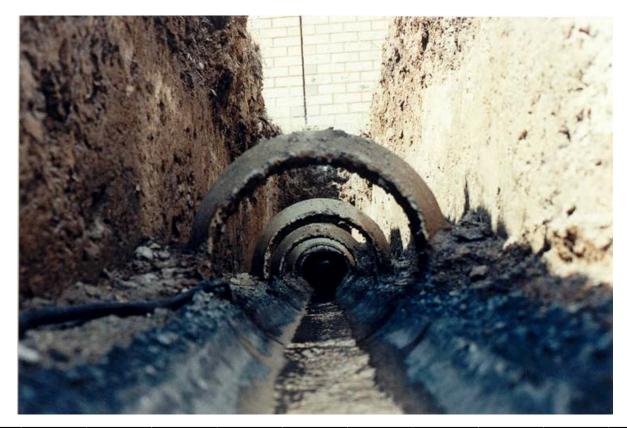
12.25 SC H SV - SURFACE DAMAGE CONCRETE, HOLE IN WALL, SOIL VISIBLE

Code	Ch1	Ch2	Q1	Q2	Circ loc'n		Joint	Long loc'n	Cont	Remarks
sc	Н		30		8	4			S1	Wall missing
sv					8	4			S2

This DN 300 concrete sewer was in service for eight years. Two pumping stations discharged into the system upstream. The pipe was inspected with mirrors from manholes about every two years and in one of these inspections it was noticed that the rubber rings were hanging down from the soffit. This could have been coded as defection joint seal hanging high (DJS-HH). The explanation for the hanging rings is that the pipe wall from 8 to 4 o'clock had completely disintegrated allowing the rubber ring (normally on the outside of the pipe) to fall unrestrained into the 'pipe space'. The rubber ring, during the life of the pipeline, prevents the corrosive gases reaching the socket component of the pipe on the outside. Hence the only part of the pipe remaining intact were the sockets and an undamaged invert.

The pipe was exhumed to reveal the situation in the photograph. Fortunately, there was no collapse because the trench backfill was well compacted cohesive soil and remained intact over the void left by the corroding pipe allowing the invert to remain functional.

Assuming this conduit was inspected prior to excavation, the top part of the concrete pipe has completed corroded away (SC-H) from 8 to 4 o'clock with soil visible (SV), both of which would be continuous.

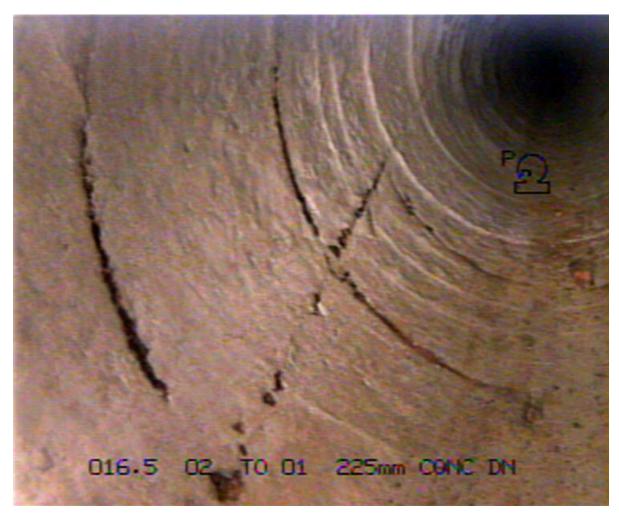
12.27 SCRV - SURFACE DAMAGE CONCRETE REINFORCEMENT VISIBLE (EXAMPLE 1)

Code	Ch1	Ch2	Q1	Q2	Circ loc'n		Joint	Long loc'n	Cont	Remarks
SC	RV				A	A				ircumferential and longitudinal einforcement visible

Steel reinforcement is visible with some minor corrosion evident (**SC-RV**) due to insufficient cover. As this is a close up view it is not possible to determine the full extent of the defect circumferentially or longitudinally. The operator would report such information and describe the defect in remarks.

The reason for the visible steel reinforcement seems to be a manufacturing fault that has resulted in the reinforcement having negligible concrete cover.

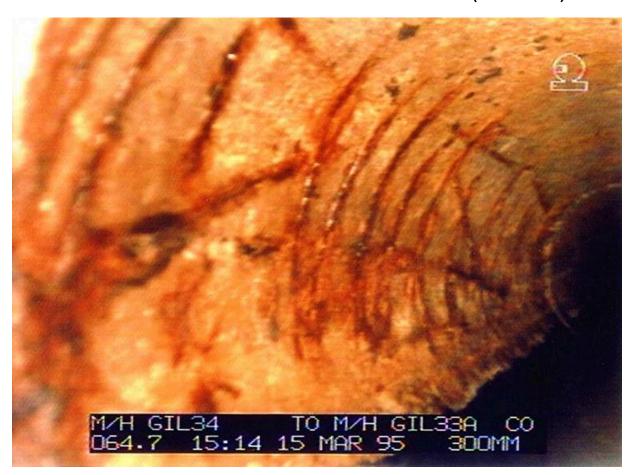
12.28 SCRV - SURFACE DAMAGE CONCRETE REINFORCEMENT VISIBLE (EXAMPLE 2)

Code	Ch1	Ch2	Q1	Q2	Circ loc'n		Joint	Long loc'n	Cont	Remarks
SC	RV				A	A		64.7	S1	No loss of concrete obvious

Steel reinforcement is visible with some corrosion evident (**SC-RV**) due to insufficient cover. As this is a partial view of the conduit internal surface it is not possible to determine the full extent of the defect circumferentially or longitudinally. The operator would report such information and describe the defect in remarks.

Despite the reinforcement corrosion, this concrete pipe appears to be in reasonable condition.

Normally exposed reinforcement is associated with loss of concrete through corrosion spalling, erosion or some other process. In this case there is no obvious reason and a remark to that effect helps to explain the observation.

Typically, the code (SC-RC) would be used to report on the loss of concrete from approximately 8-4 o'clock, with maximum loss at the obvert and significant corrosion of the steel reinforcement. However, in this photo, there is no apparent loss of concrete at the obvert.

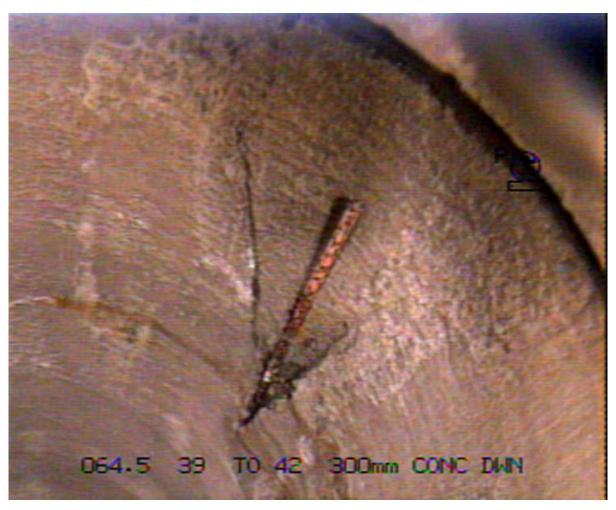
I2.29 SCRVP_CL - SURFACE DAMAGE CONCRETE REINFORCEMENT VISIBLE AND PROJECTING, CRACKING LONGITUDINAL

Code	Ch1	Ch2	Q1	Q2	2 Circ loc'n		Joint	Long loc'n	Cont	Remarks
sc	RVP				2			64.5		
С	L		1		2			64.5

In addition, a longitudinal crack (C-L) at with a width of about 1 mm is propagating from the 'root' of the reinforcement towards the joint.

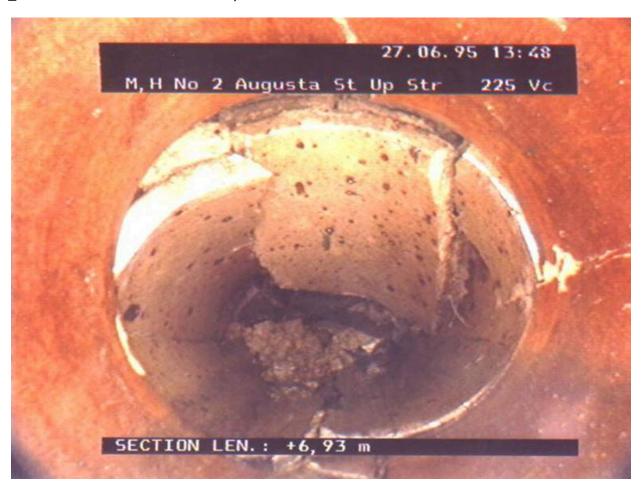
12.30 X SAOB - COLLAPSED CONDUIT, SURVEY ABANDONED OBSTRUCTION

Code	Ch1	Ch2	Q1	Q2	Circ lo	oc'n	Joint	Long loc'n	Cont	Remarks
х										Localised to 600 mm length
SA	ОВ									Conduit collapsed

The conduit has broken with all displaced pieces present, but sufficiently for it to be reported as a collapse (**X**). Individual pieces of conduit have dropped to reduce the diameter by more than 25%. Reporting broken displaced is not required. The collapse distance estimated at **600** mm is recorded in the remarks.

This is obviously the end of the inspection as the camera can progress no further. The inspection has to be abandoned due to the obstruction caused by the collapse (**SA-OB**). Conduit collapsed is recorded in the remarks.

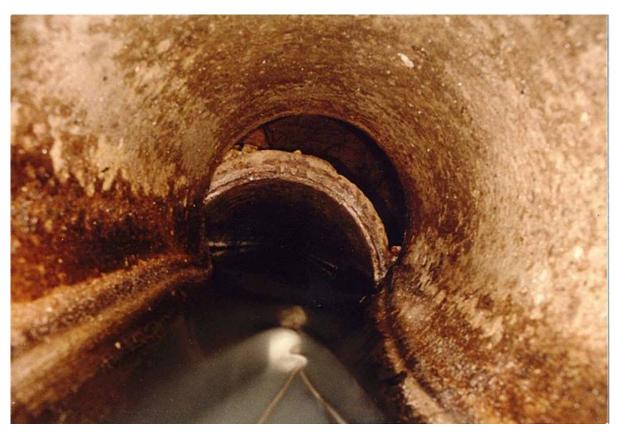
12.31 X VV SAOB - COLLAPSED CONDUIT, VOID VISIBLE, SURVEY ABANDONED OBSTRUCTION

Code	Ch1	Ch2	Q1	Q2	Circ loc'n		Joint	Long loc'n	Cont	Remarks
х			900					A		Collapsed conduit length undamaged and repairable
vv					10	4		Α		
SA	ОВ

The defect at this location is an extreme radial displacement at a joint. It appears that the whole conduit length has been displaced and that the displacement is so large a void is visible (**VV**) outside the conduit.

This is obviously the end of the inspection as the camera can progress no further. The inspection has to be abandoned due to the obstruction caused by the collapse (**SA-OB**).

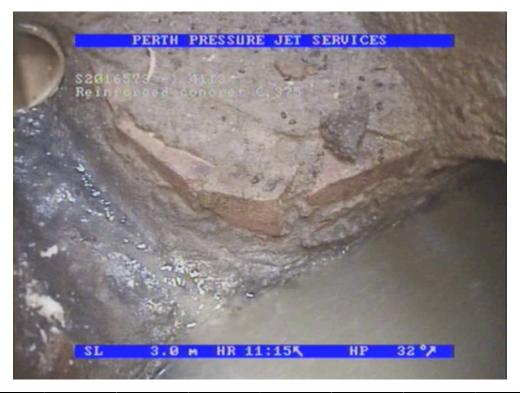
13.1 HCH_D_HBE_D - CHANNEL DEFECTIVE, BENCHING DEFECTIVE

Code	Ch1	Ch2	Q1	Q2	Circ loc'n		Desc loc'n	Vert loc'n	Remarks
нсн	D		A	A	9	12	ı	3.3	Loss of render on side of channel
НВЕ	D				9	12	н	3.3	Adjacent to loss of render in channel

Part of the rendered cement mortar over 'infill' brickwork in the channel, descriptive location **I**, is missing (**HCH-D**). The missing mortar extends to the part of the bench and that is reported with a remark. The lining defective code (HLD-RM) could have been used but the defect is so specific to the channel that it is more appropriate to code as above.

To illustrate complete coding the benching condition coding is (**HBE_D**) has been included to report on minor loss of rendering on the benching.

Channel dimensions Q1 and Q2 are not available, and are given the value A for applicable in this example.

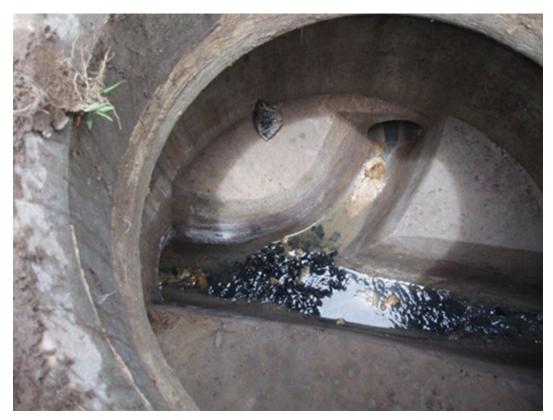
13.2 HDER - DEPOSITS COARSE SEDIMENTS

Code	Ch1	Ch2	Q1	Q2	Circ loc'n		Desc loc'n	Vert loc'n	Remarks
HDE	-	R	20		12		_	A	Main channel – ponding at outlet

The observation is recorded as being at the channel, which is descriptive location **I.** The vertical location (distance) is not recorded but is applicable and noted as **A.**

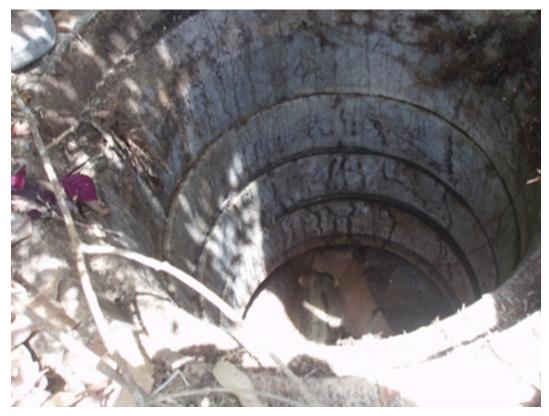
13.3 HGC - GENERAL COMMENT

Code	Ch1	Ch2	Q1	Q2	Circ loc'n		Desc loc'n	Vert loc'n	Remarks
HGC									MH constructed from four make- up rings on top of squat cone

This MH is constructed with a squat cone extended to the surface with four make-up rings. This construction was found during an audit and was not marked on the as-constructed plans. It included an inlet from an unmarked line that was found to have 8 upstream MHs, none of which were shown on the plans.

The general comment about the construction of this maintenance hole is warranted. However, a complete inspection would have revealed precise record of the construction and other features.

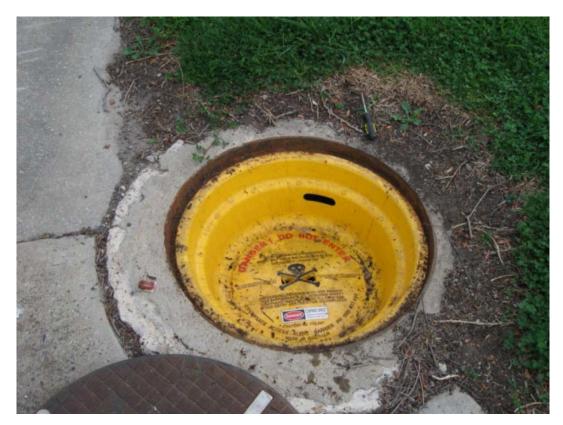
13.4 HGTAB - DEVICE UNDER COVER ACCESS BARRIER

Code	Ch1	Ch2	Q1	Q2	Circ loc'n		Desc loc'n	Vert loc'n	Remarks
HGT	AB								Safety barrier

An access barrier is present under the cover (**HGT-AB**). The device provides a risk control measure for ensuring the safety of those who must enter or carry out tasks associated with a confined space.

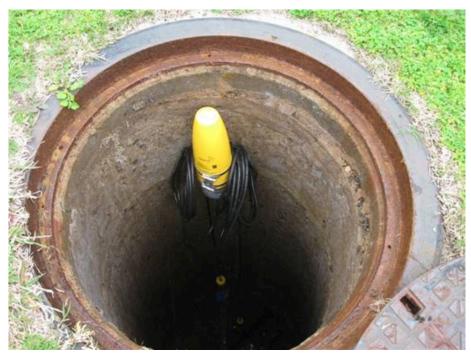
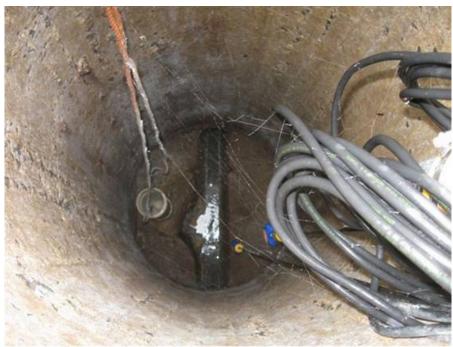
13.5 HGTSD - DEVICE UNDER COVER SENSING DEVICE

Code	Ch1	Ch2	Q1	Q2	Circ loc'n		Desc loc'n	Vert loc'n	Remarks
HGT	SD								Level sensing device

A sensing device is present under the cover (**HGT-SD**). The level sensors at the bottom of the MH are used to provide information on when discharge to an overflow (obscured at bottom of MH) will occur. The cables are attached to the monitor (yellow pod) that communicates via SCADA when certain levels have been reached.

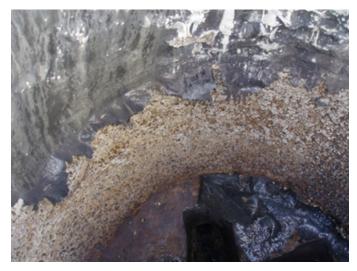
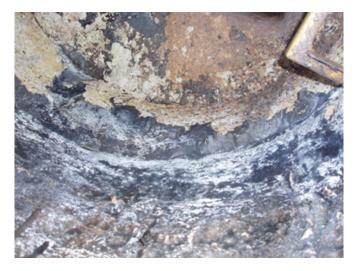
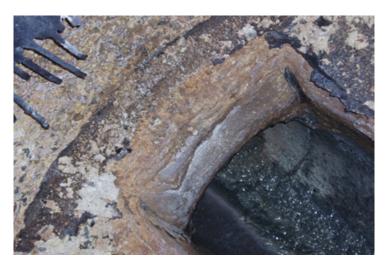
13.6 HLDP - DEFECTIVE LINING COATING PEELING OFF

Code	Ch1	Ch2	Q1	Q2	Circ loc'n		Desc loc'n	Vert loc'n	Remarks
HLD	P				12	12	A	A	Benching, shaft sections, make- up rings

This coding entry is indicative only. The peeling coating would most likely be first reported immediately below the cover frame descriptive location B (adjusting construction). If extending over one metre, it would be recorded as continuous. Aggregate projecting (HSCAP) would also need to be reported where the coating had been lost.

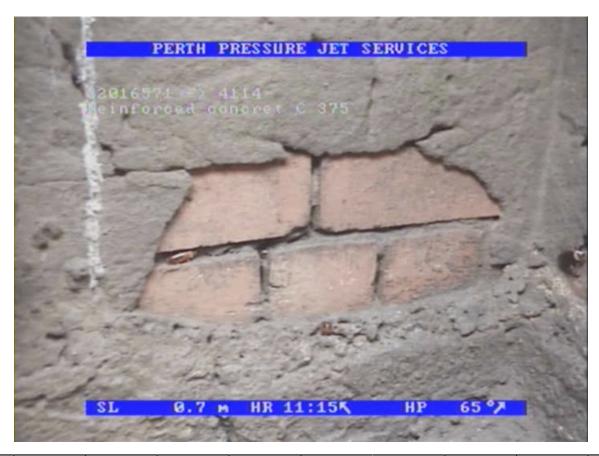
13.7 HLDRM - DEFECTIVE LINING RENDERED MORTAR MISSING

Code	Ch1	Ch2	Q1	Q2	Circ loc'n		Desc loc'n	Vert loc'n	Remarks
HLD	RM				Α	A	F	A	Rendering missing with cracking in remaining mortar

Part of the rendered cement mortar of this brickwork is cracked and missing (**HLD-RM**). It is not clear where in the circumference that the defect occurs, so the circumferential extent has been noted as **A** for applicable, as is the vertical location. The descriptive location is **F**, the chamber.

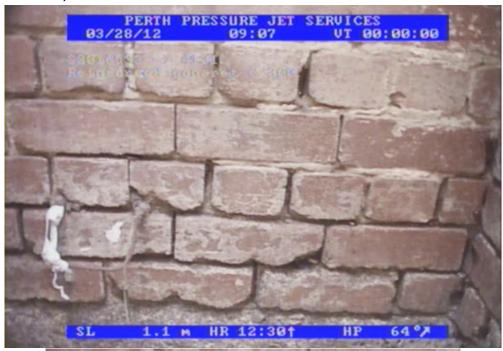
I3.8 HMM_HSOS_HSLSB_HSLSC - MISSING MORTAR, SURFACE DAMAGE OTHER SPALLING, DEFECTIVE STEP BENT, DEFECTIVE STEP ENCAPSULATION DAMAGED

Code	Ch1	Ch2	Q1	Q2	Circ loc'n		Desc loc'n	Vert loc'n	Remarks
нмм			20		12	12	F	Α	
нѕо	S				12	12	F	A	Spalling on edges of bricks around full circumference
HSL	SB		1		A		F	1.1	Severely corroded step iron
HSL	sc		1		Α		F	1.1

The brickwork of this MH exhibits missing mortar (**HMM**) and spalling (**HSO-S**). The step iron is bent (**HSL-EB**) and is also severely corroded (**HSL-SC**). The missing mortar and spalling most likely could have been recorded as a continuous defect in this maintenance hole.

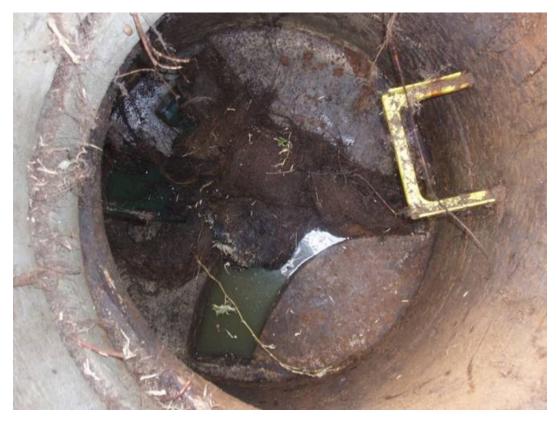
13.9 HRM_HRF - ROOTS MASS, ROOTS FINE

Code	Ch1	Ch2	Q1	Q2	Circ loc'n		Desc loc'n	Vert loc'n	Remarks
HR	М		100		12	8	ı	А	Roots blocking outlet and extending in channel to inlet at 8 o'clock
HR	F			<5	A	A	В	A	Roots coming through joints in make- up rings

Observations have omitted values for vertical location and for roots coming through make up rings the circumferential, and the extent is indicated by **A** for applicable.

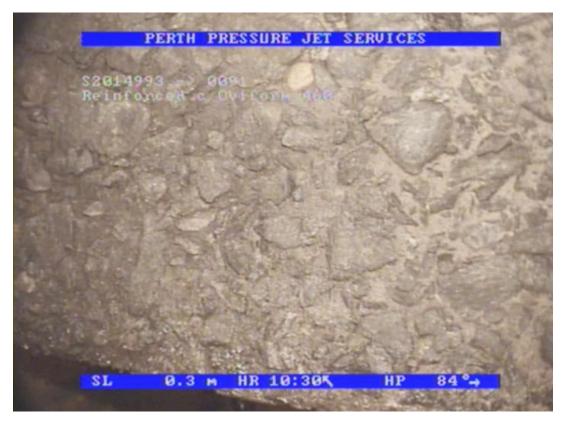
13.10 HSCAP - SURFACE DAMAGE CONCRETE AGGREGATE PROJECTING

Code	Ch1	Ch2	Q1	Q2	Circ	loc'n	Desc loc'n	Vert loc'c	Remarks
HSC	AP				Α	Α	E	0.3

The concrete surface of the reducing slab has been corroded with coarse aggregate projecting (HSC-AP).

Circumferential location cannot be identified from photo, and is recorded as **A** for applicable.

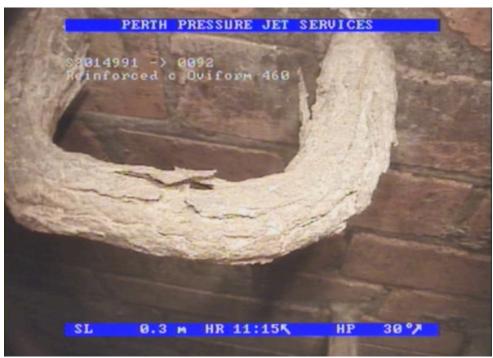
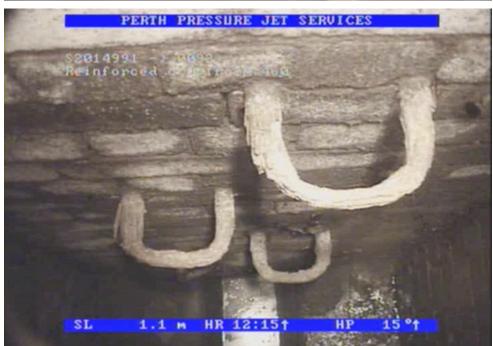
I3.11 HSLSC - DEFECTIVE STEP CORRODED

Code	Ch1	Ch2	Q1	Q2	Circ loc'n		Desc loc'n	Vert loc'n	Cont	Remarks
HSL	sc		6		12		F	0.3	S1

The 6 step irons in this MH are corroded (**HSL-SC**). The continuous notation has been used in this case to indicate the corroded step irons extend over a significant part of the structure. In this example the defect step irons extend over one metre.

The continuous notation may also be used for defects similar to the step irons depicted, even though the extent may be less than one metre.
